**Sample Property**

Greater Toronto Area, ON

SAMPLE REPORT · CLIENT DETAILS REMOVED

## Aerial Roof Inspection Report

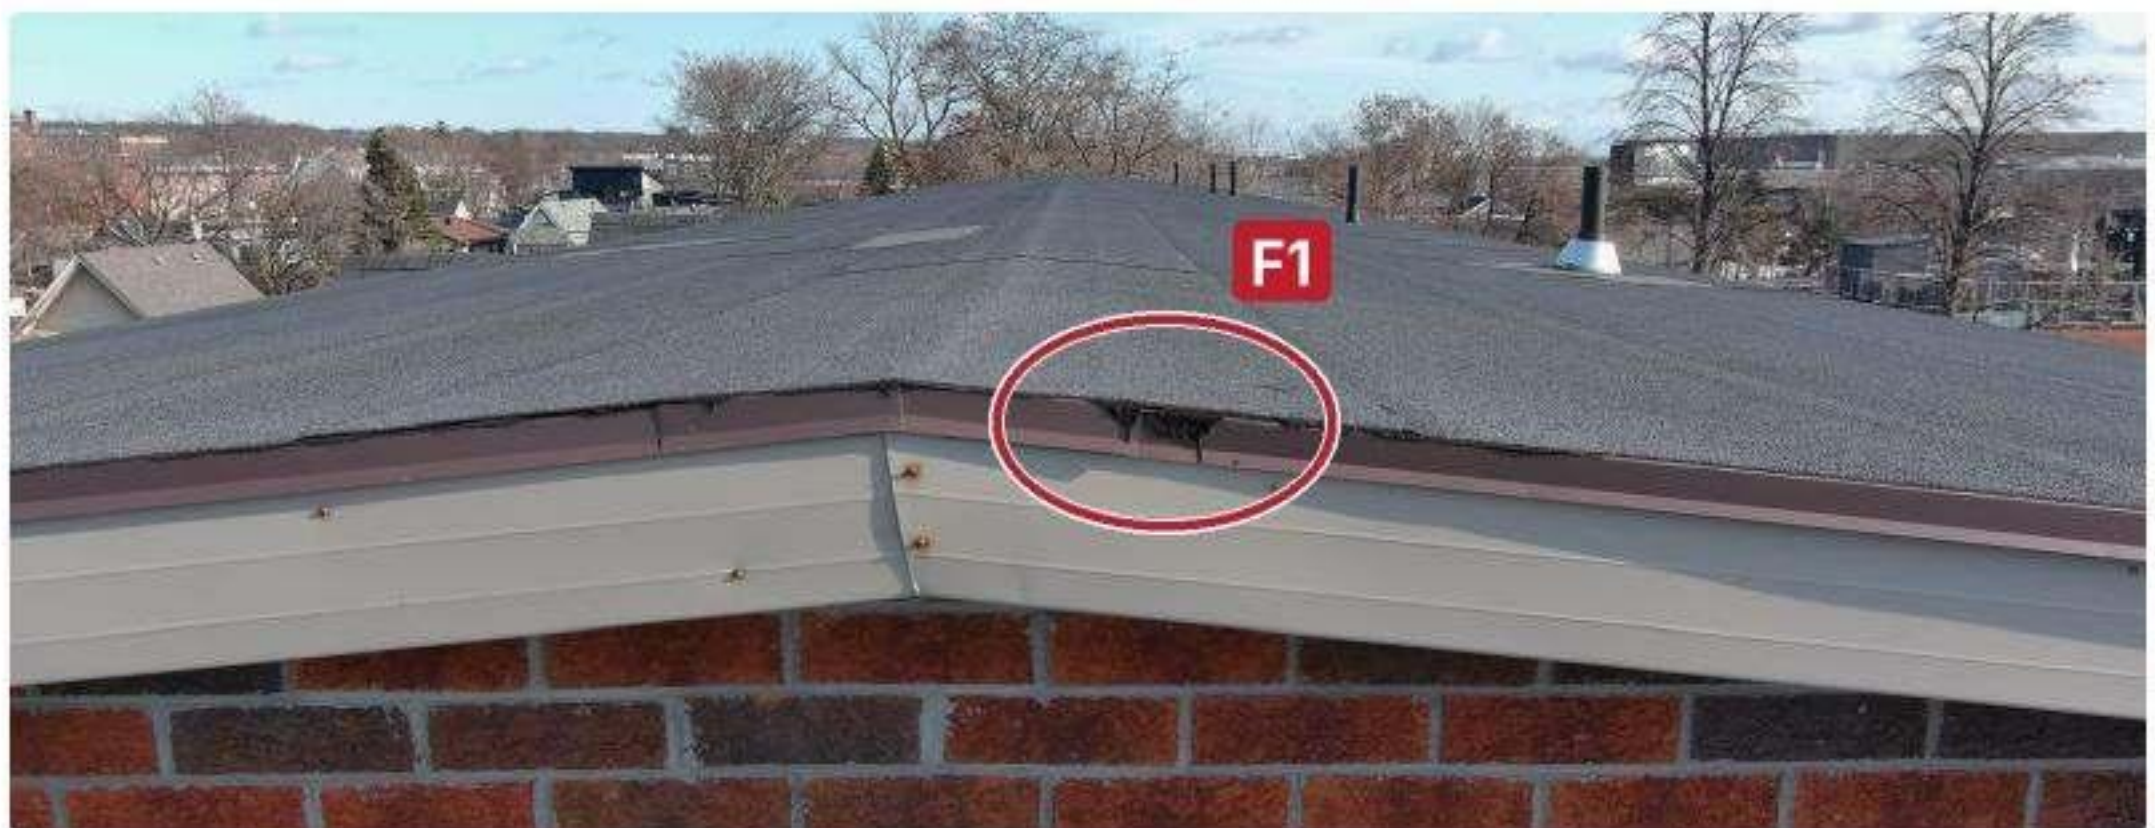
Photo 102

# F1 Open / deteriorated membrane edge at end-wall corners

Along the perimeter edge of the low-slope membrane at the end wall, the membrane edge is irregular and appears lifted, with dark exposed bitumen and small openings visible where the membrane meets the metal edge flashing – most noticeably at the corner where the roof plane changes direction.

Open membrane edges allow wind-driven rain and meltwater to get under the membrane and behind the fascia. This is a common entry point for leaks into the top-floor ceiling and wall cavities, and can lead to wind uplift of the membrane during storms.

F1.1 – Lifted, open membrane edge at the corner of the end wall.

Have a roofing contractor re-adhere and seal the membrane edge (heat-weld or approved flashing cement and a membrane strip-in) along the full end-wall perimeter, and check the metal edge flashing fasteners.

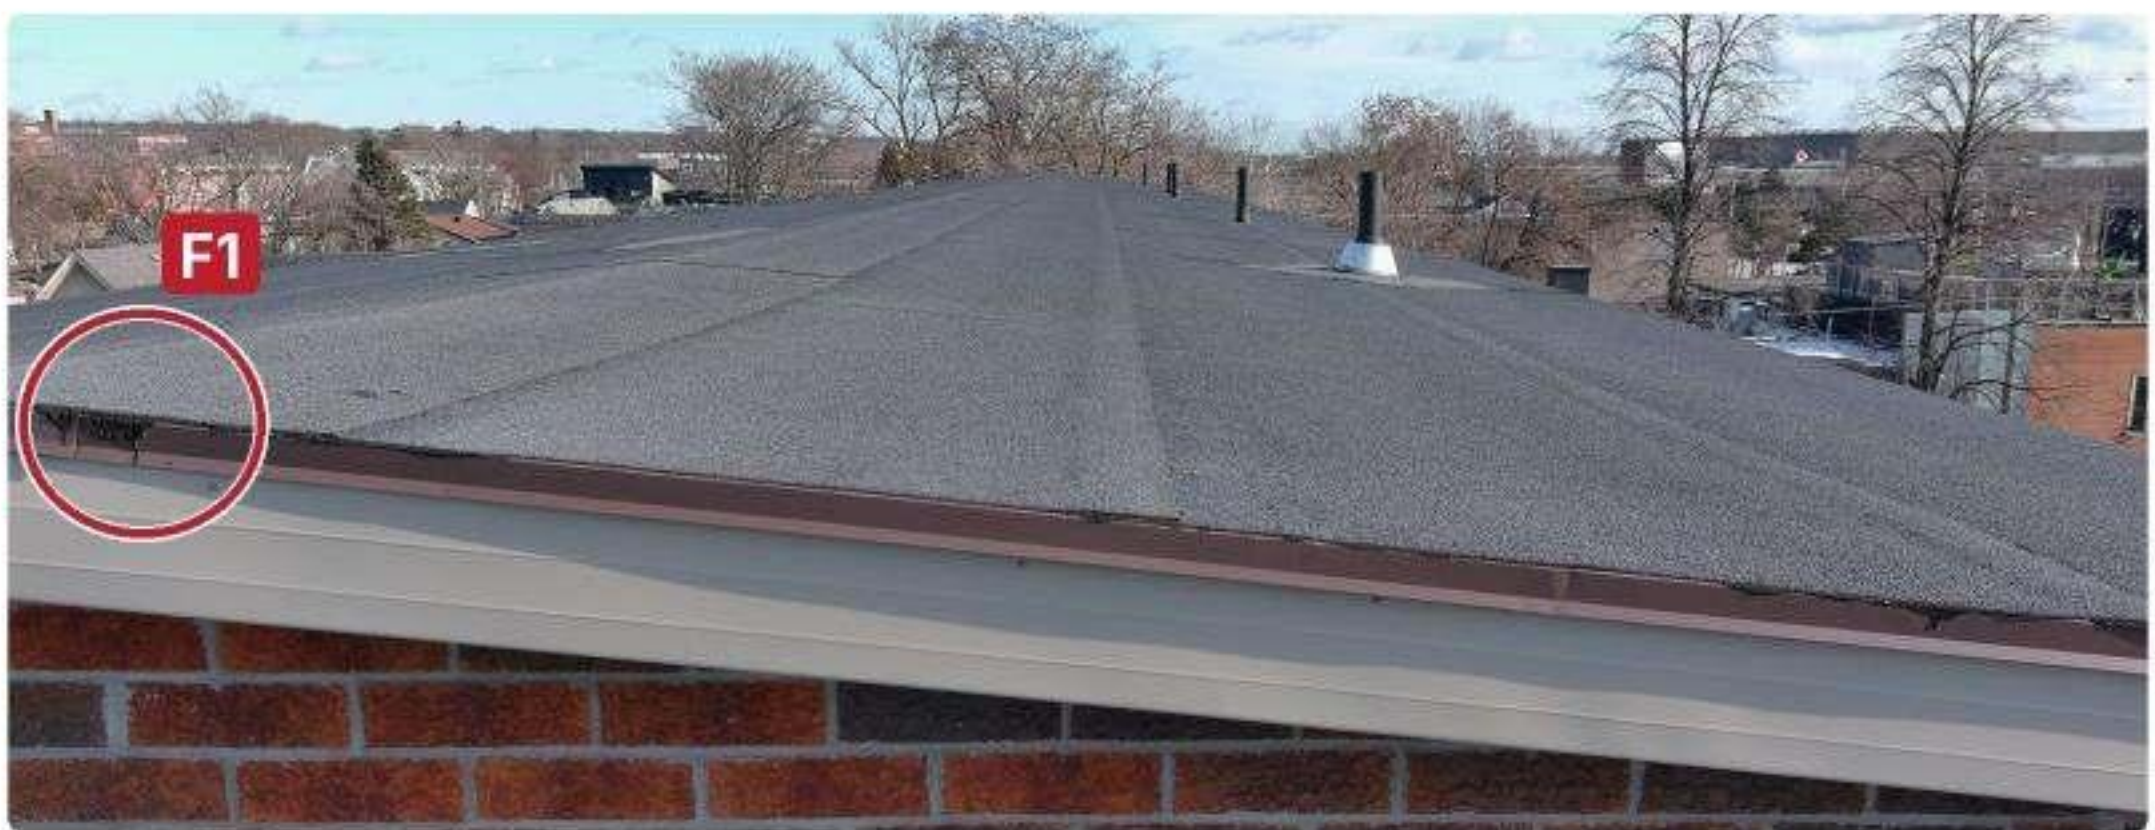
Photo 103

F1.2 – Irregular edge with exposed bitumen along the perimeter flashing.

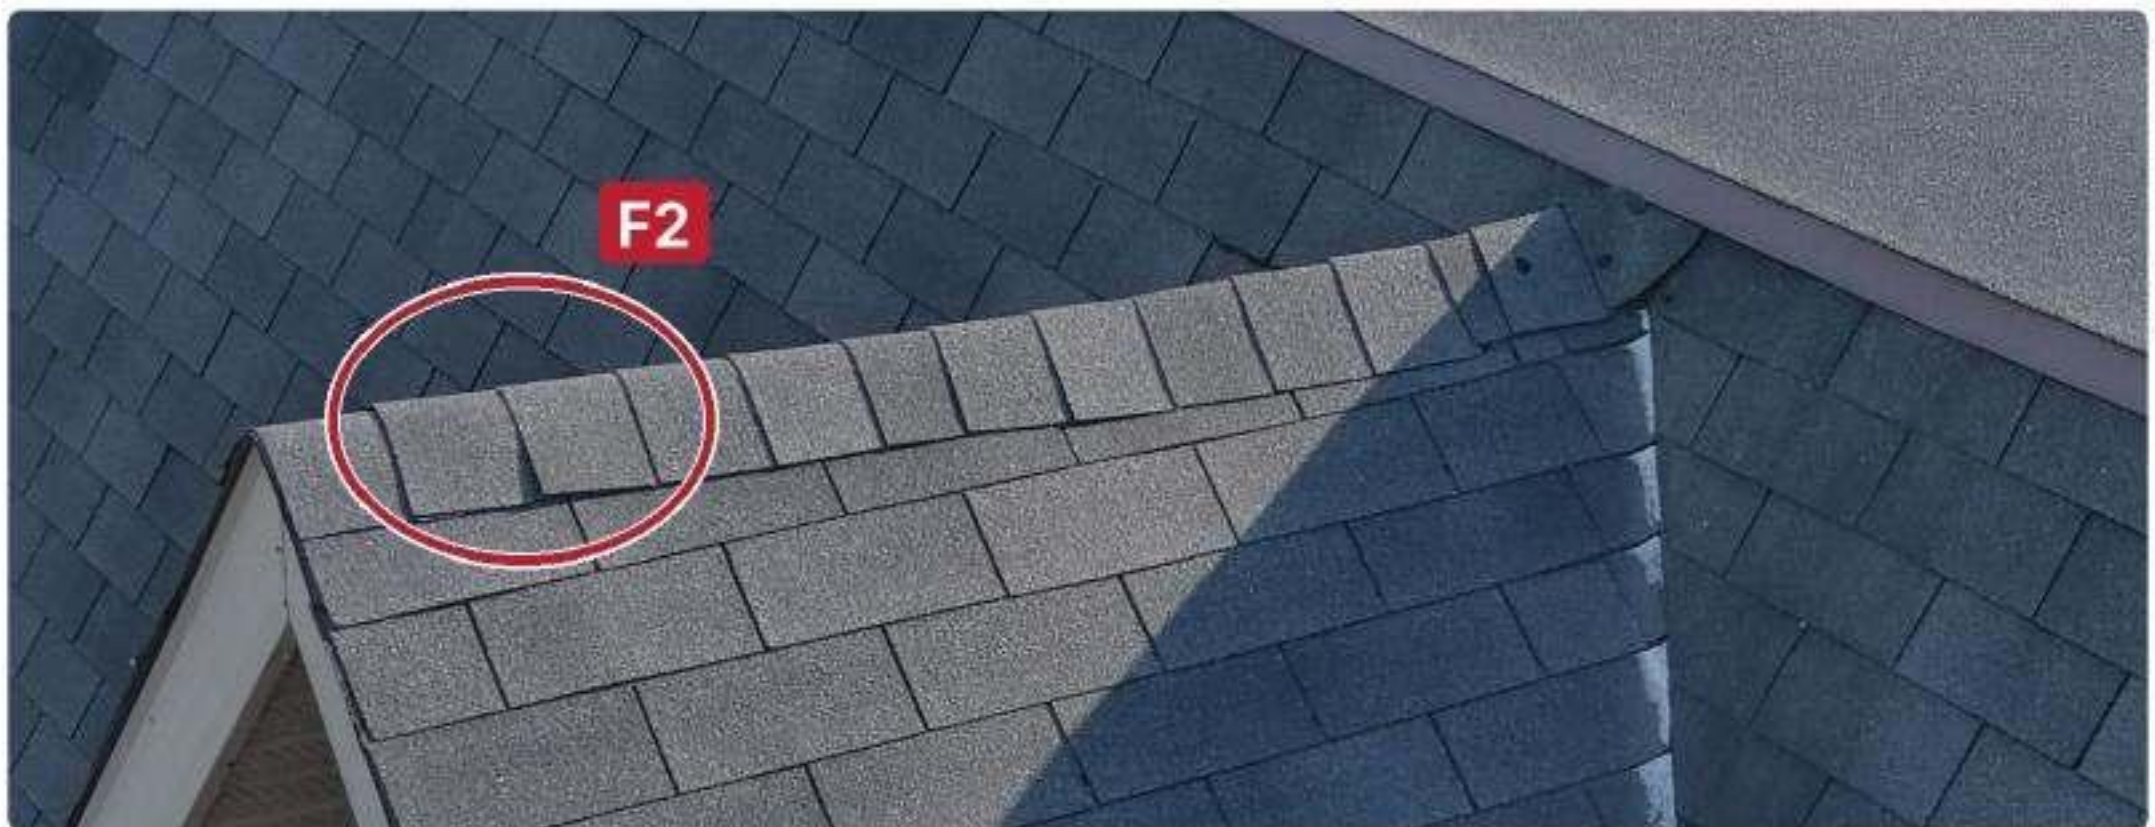
Photo 25

Several ridge-cap shingles on the dormer ridges are raised or out of line, particularly near the dormer peak and where the dormer ridge ties into the main slope. The cap shingles do not appear fully sealed down.

Unsealed ridge caps are vulnerable to wind blow-off and let water reach the ridge nails and roof deck. Dormer ridges are exposed and often the first place shingles are lost in high winds.

F2.1 – Raised ridge-cap shingle at the dormer ridge.

Re-seal lifted ridge caps with roofing cement and replace any cracked or deformed caps. Inspect all dormer ridges in the row for the same condition.

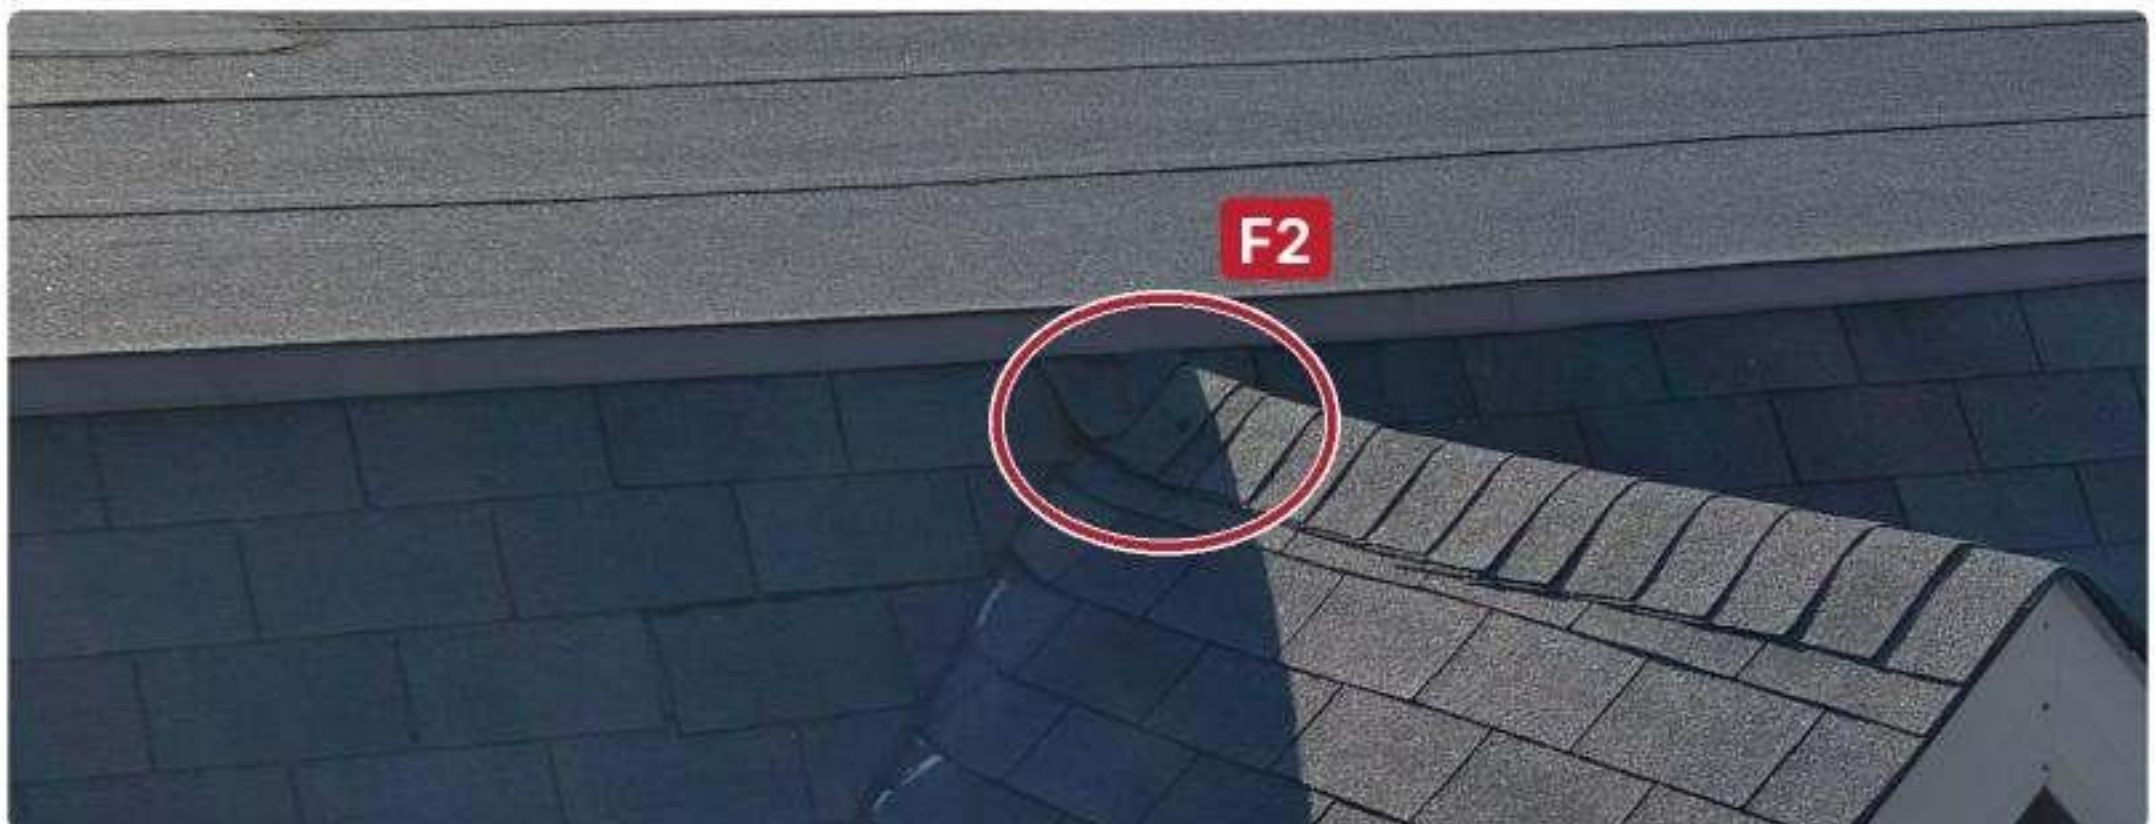
Photo 9

F2.2 – Raised cap shingles where the dormer ridge ties into the main slope.

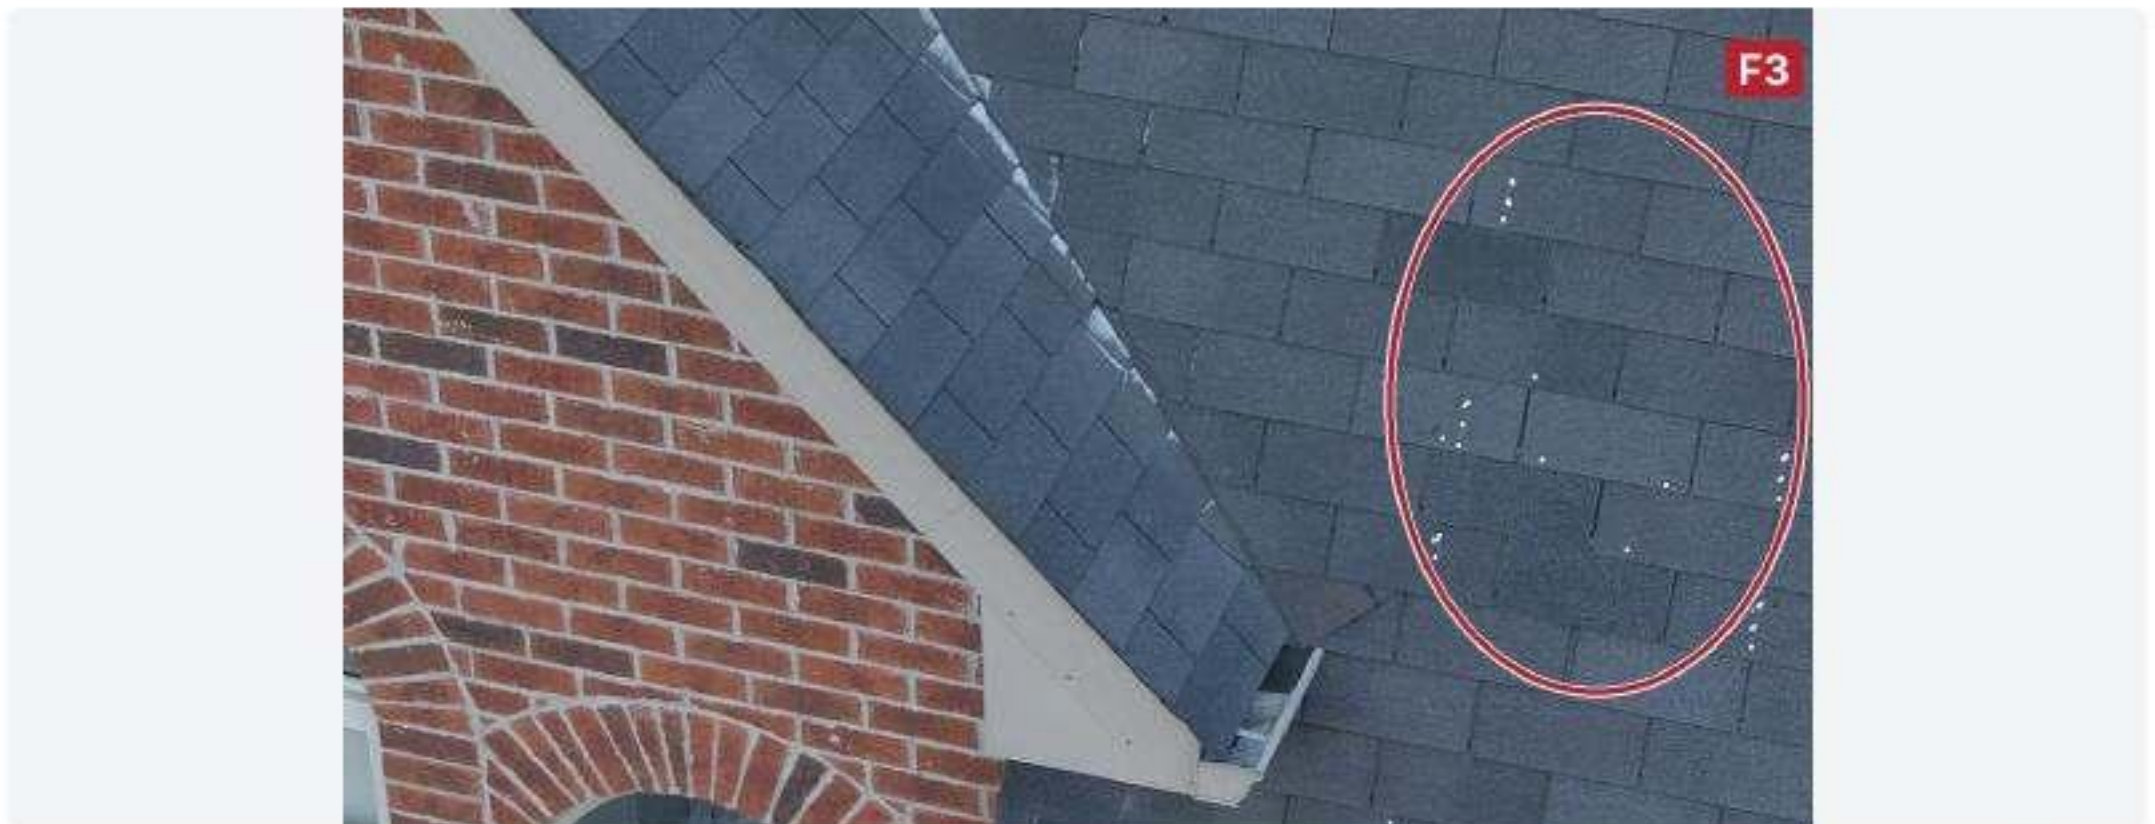
Photo 20

Numerous light-coloured spots arranged in vertical lines are visible on the shingle tabs, consistent with exposed (face-nailed) fasteners or sealant dabs from past repairs. Darker replacement shingles that do not match the surrounding field, and a section with a visible tar line across the tabs, also indicate previous patching.

Exposed fasteners and surface sealant are not a permanent watertight repair. Sealant shrinks and cracks with UV exposure and freeze-thaw cycles, and each exposed nail is a potential leak point. Clusters of repairs can also indicate a recurring problem area.

**F3.1** – Rows of exposed fasteners / sealant dabs and a mismatched replacement shingle.

Have a roofer verify the repairs up close. Replace face-nailed shingles with properly nailed, sealed shingles, or at minimum re-seal all exposed fastener heads. Ask the owner or previous contractor whether there is a history of leaks in this area.

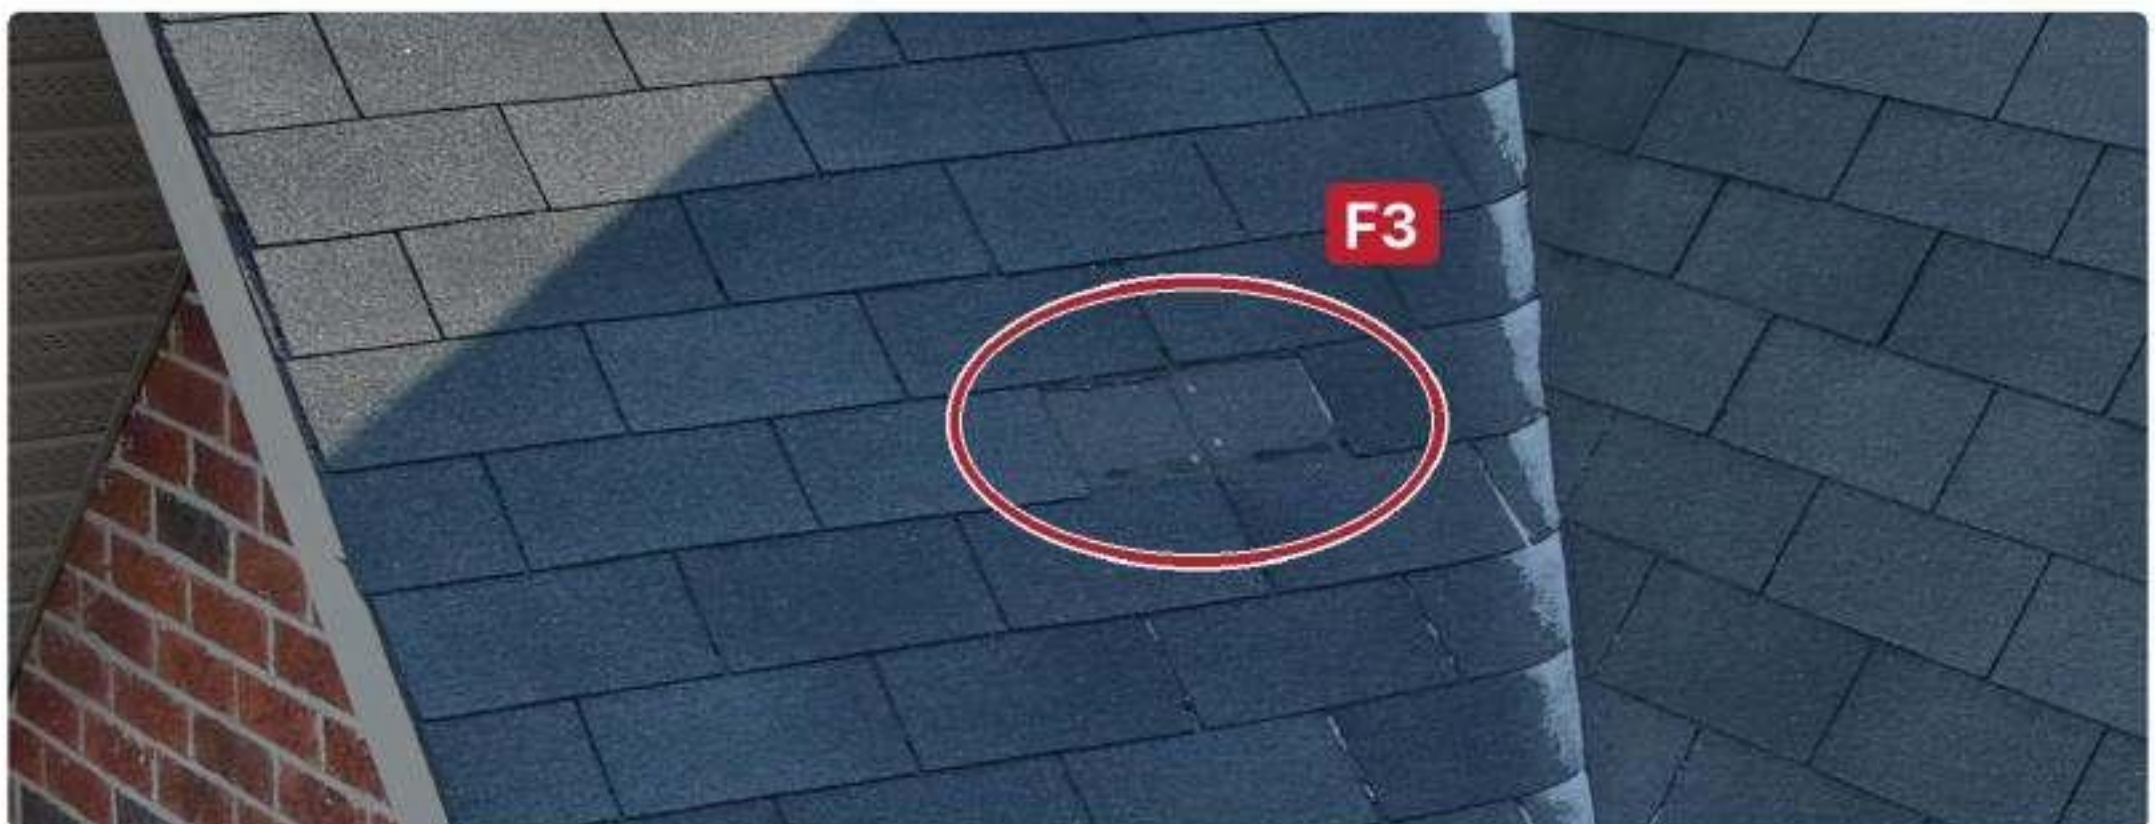
Photo 23

**F3.2** – Repaired shingles with face nails and a visible tar line.

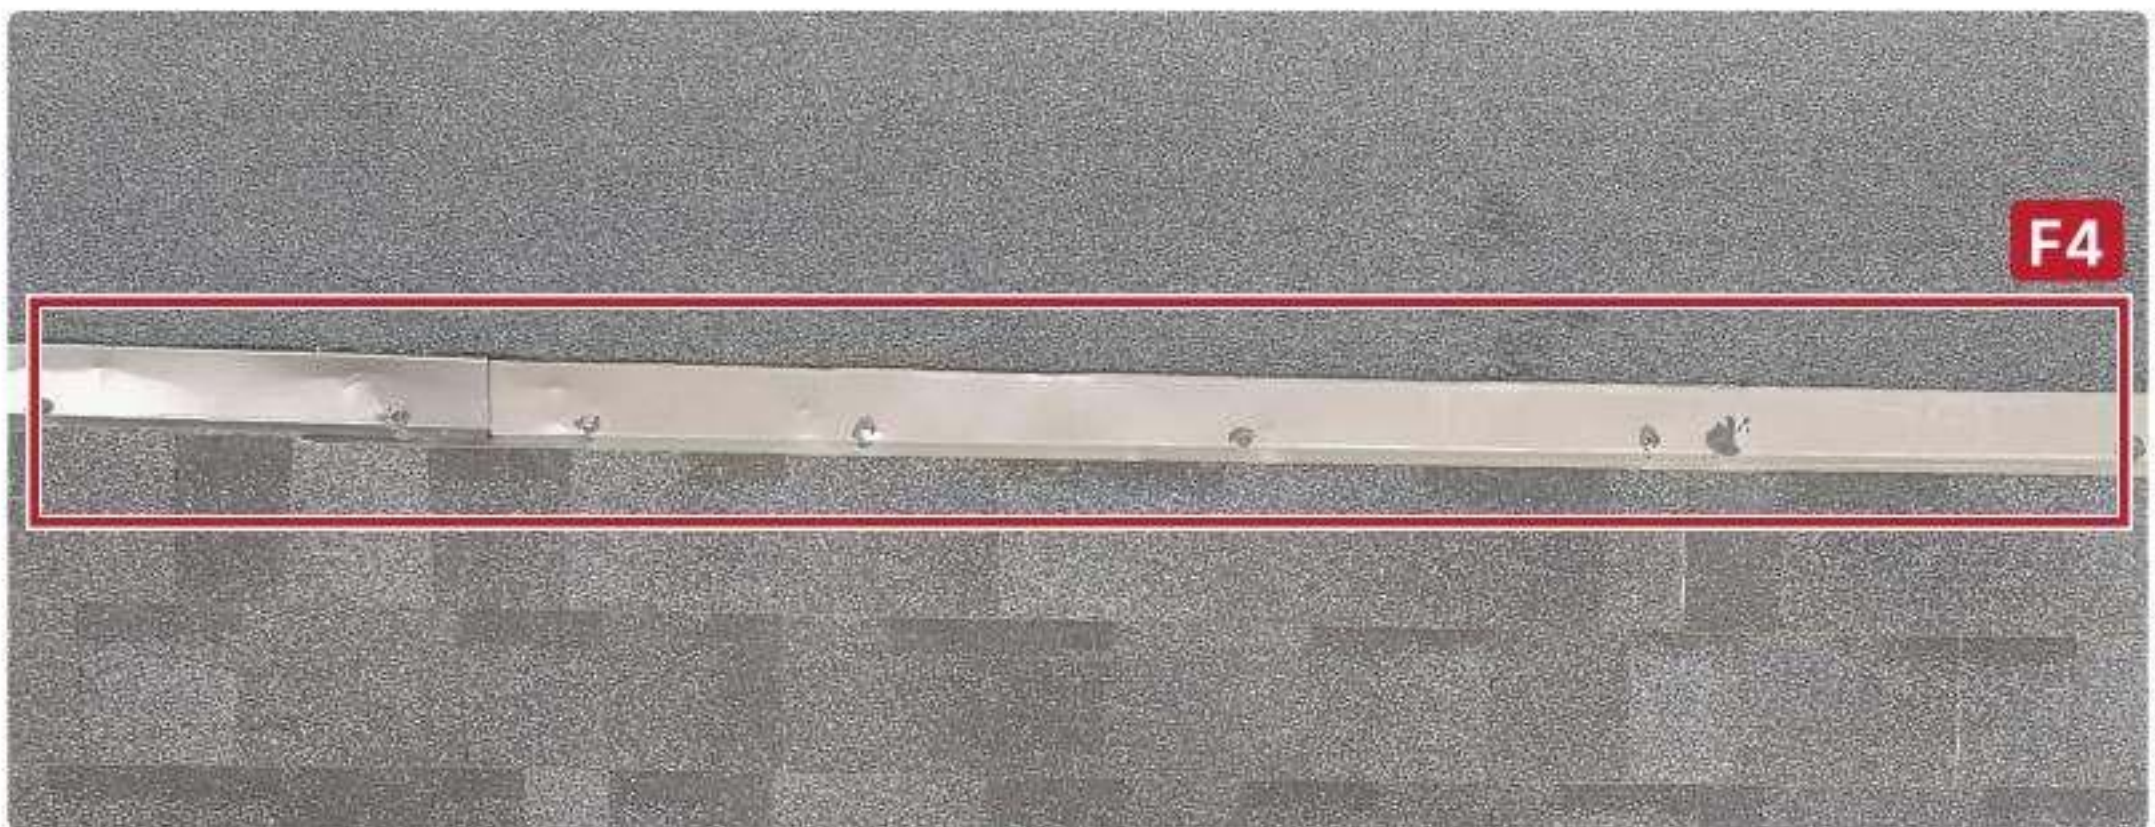
Photo 62

The metal flashing where the steep rear slope meets the low-slope roof is face-fastened, with the fastener heads covered in sealant dabs. Some sealant has weathered, a few flashing laps are raised or buckled, and minor dents are visible along its length.

This transition handles all of the water running off the upper roof. If the sealant fails or a lap opens, water can get behind the flashing and into the wall/roof junction, which is difficult to trace once it leaks inside.

F4.1 – Face-fastened transition flashing with sealant-covered fasteners and dents.

Re-seal all exposed fasteners with a compatible sealant, re-secure and seal raised lap joints, and plan for re-flashing this transition when the low-slope membrane is next replaced.

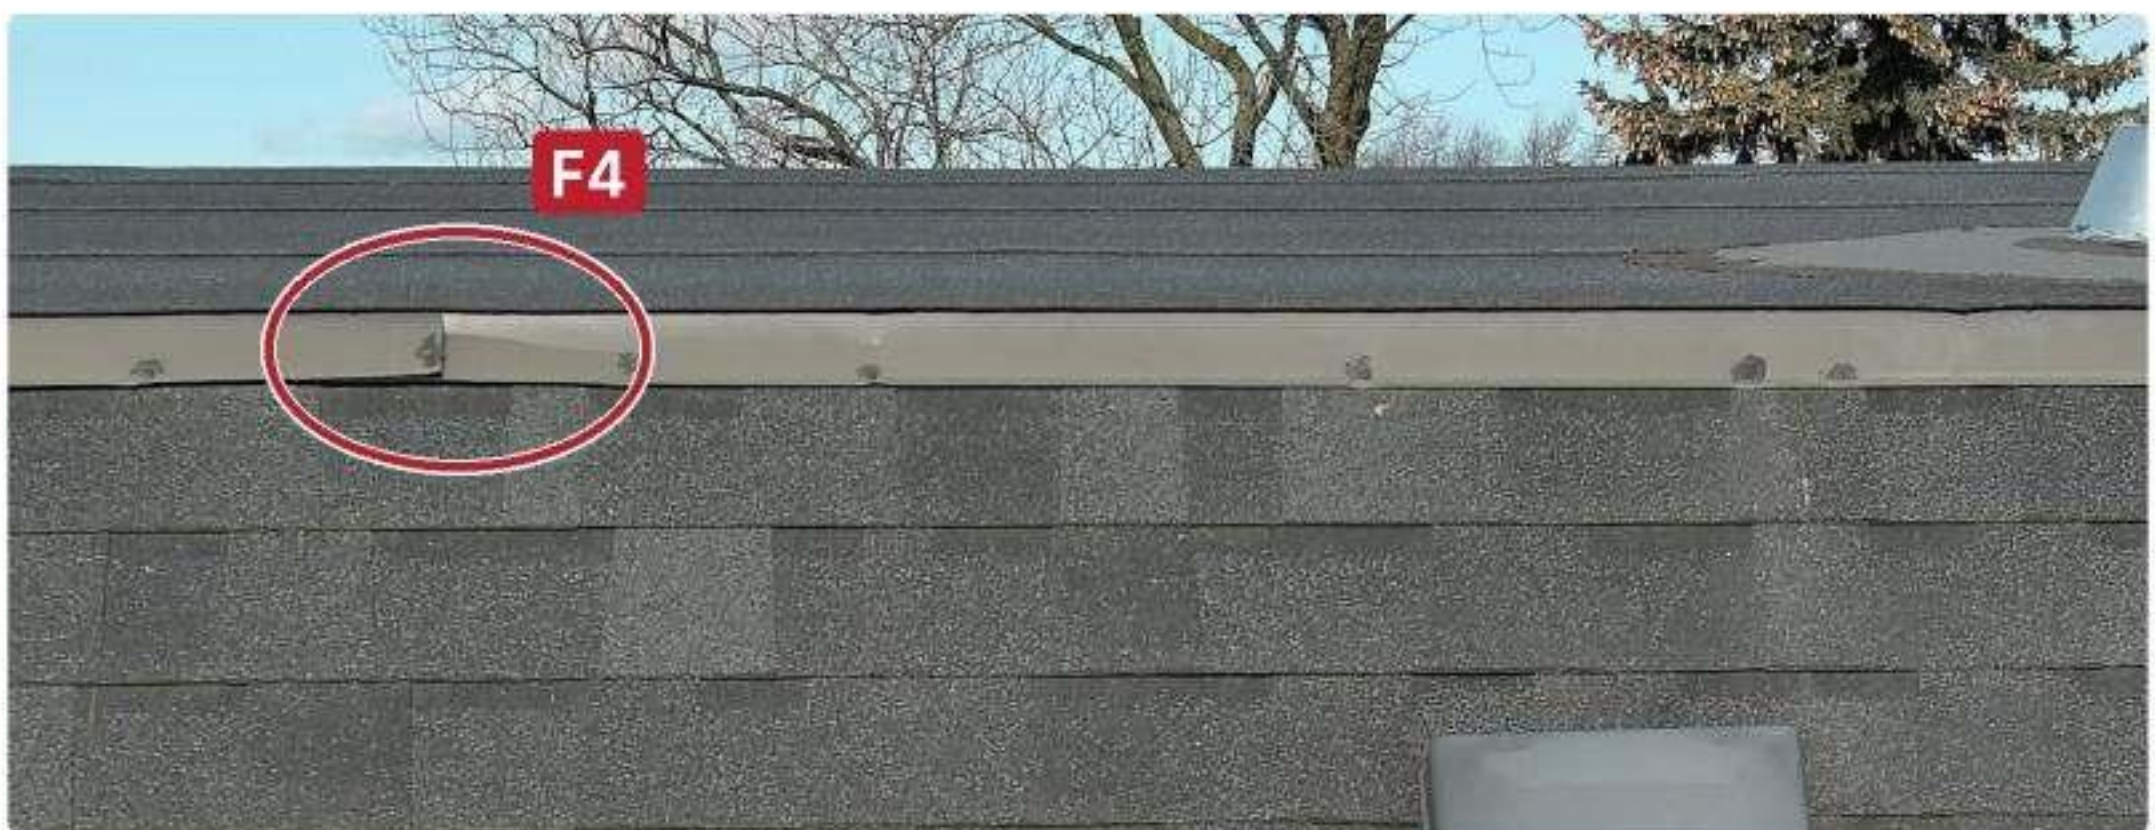
Photo 120

F4.2 – Raised / buckled flashing lap joint.

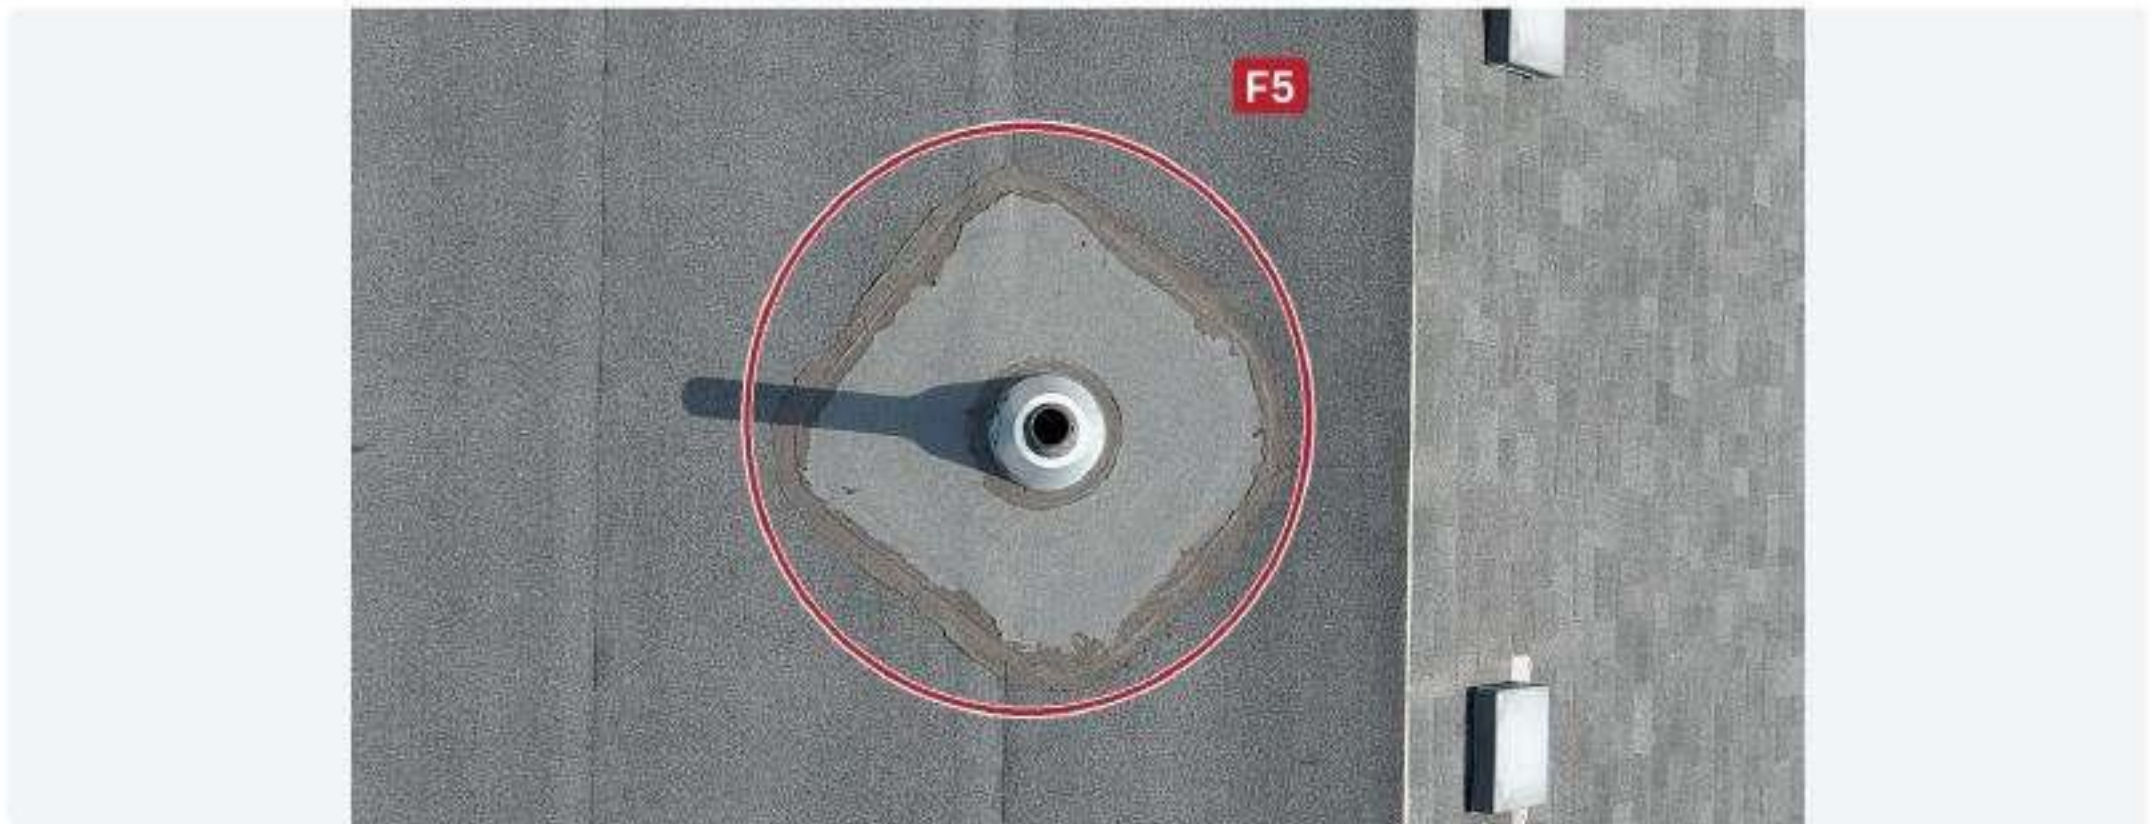
Photo 56

The low-slope membrane has many rectangular and rounded target patches (likely over removed vents or previous repairs) and large patches around each plumbing stack. The patch edges are sealed with flashing cement that appears weathered and uneven in places.

Patch edges are the weakest points of a membrane roof. As the sealant ages it can crack and open, allowing water under the patch. The number of patches also indicates the membrane has been repaired many times and may be in the later part of its service life.

F5.1 – Patched plumbing-stack penetration with weathered sealant edge.

Have each patch and stack flashing probed and re-sealed where the edge is open or cracked. Include the low-slope roof in annual maintenance and start budgeting for membrane replacement.

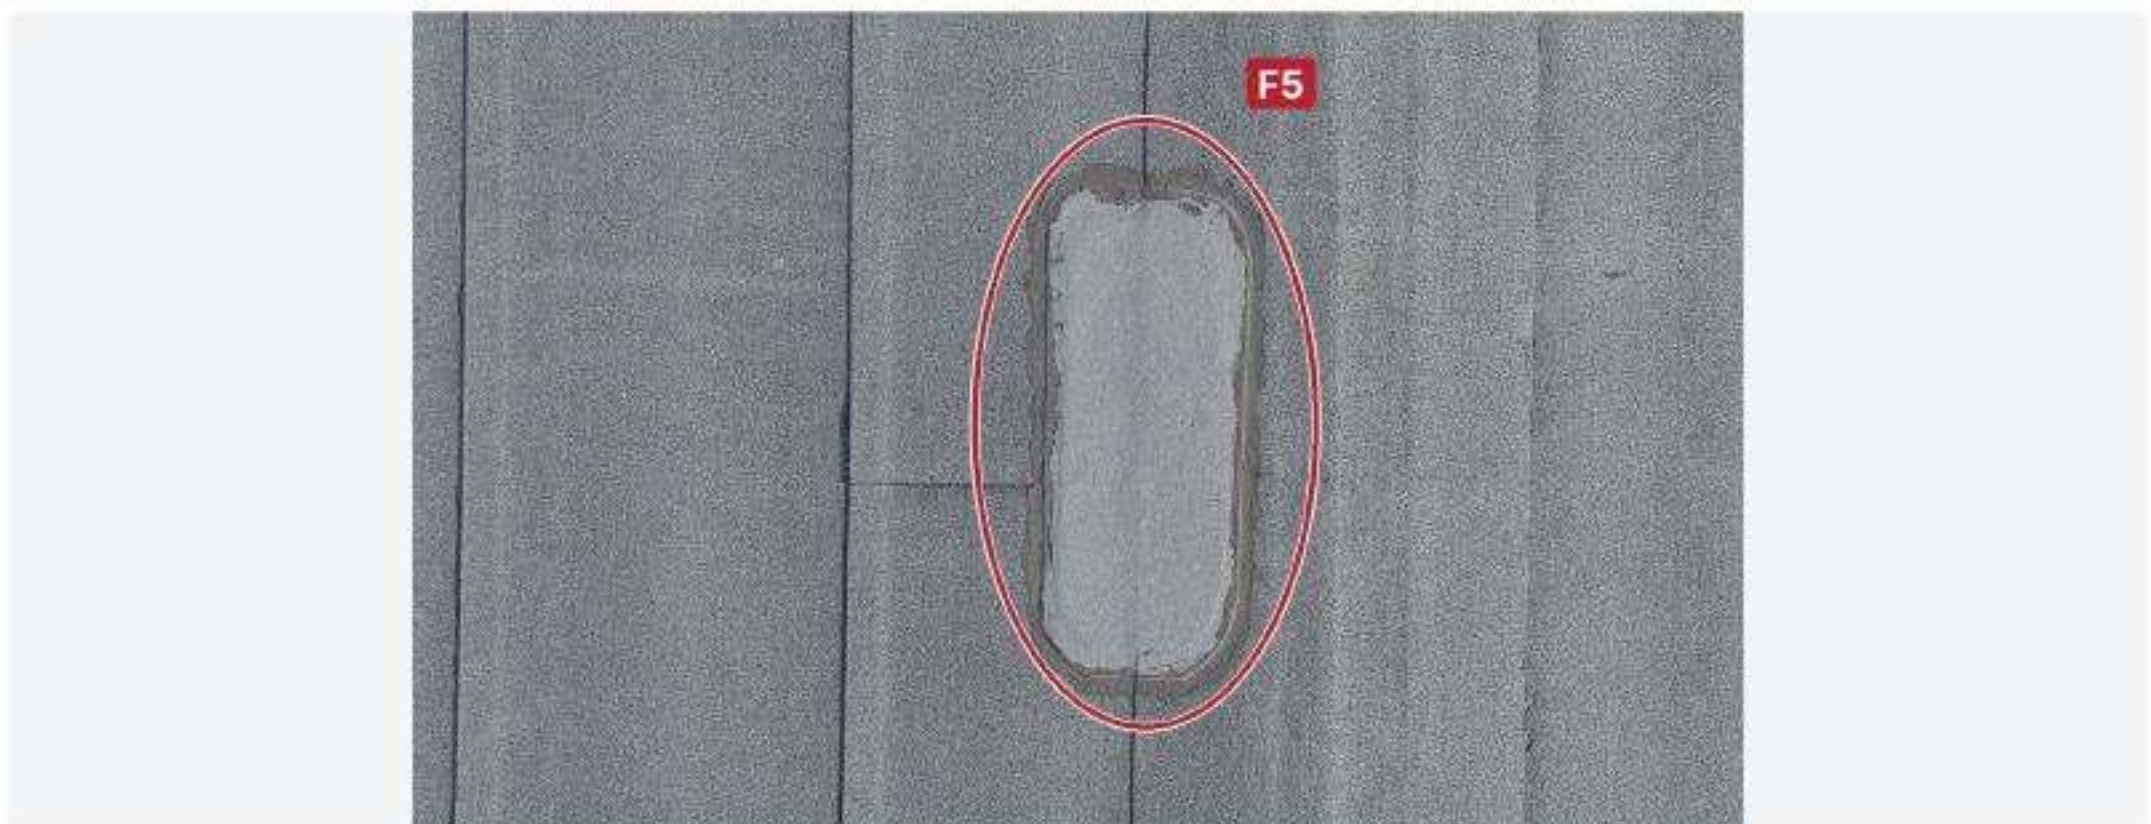
Photo 55

F5.2 – Rectangular target patch on the membrane.

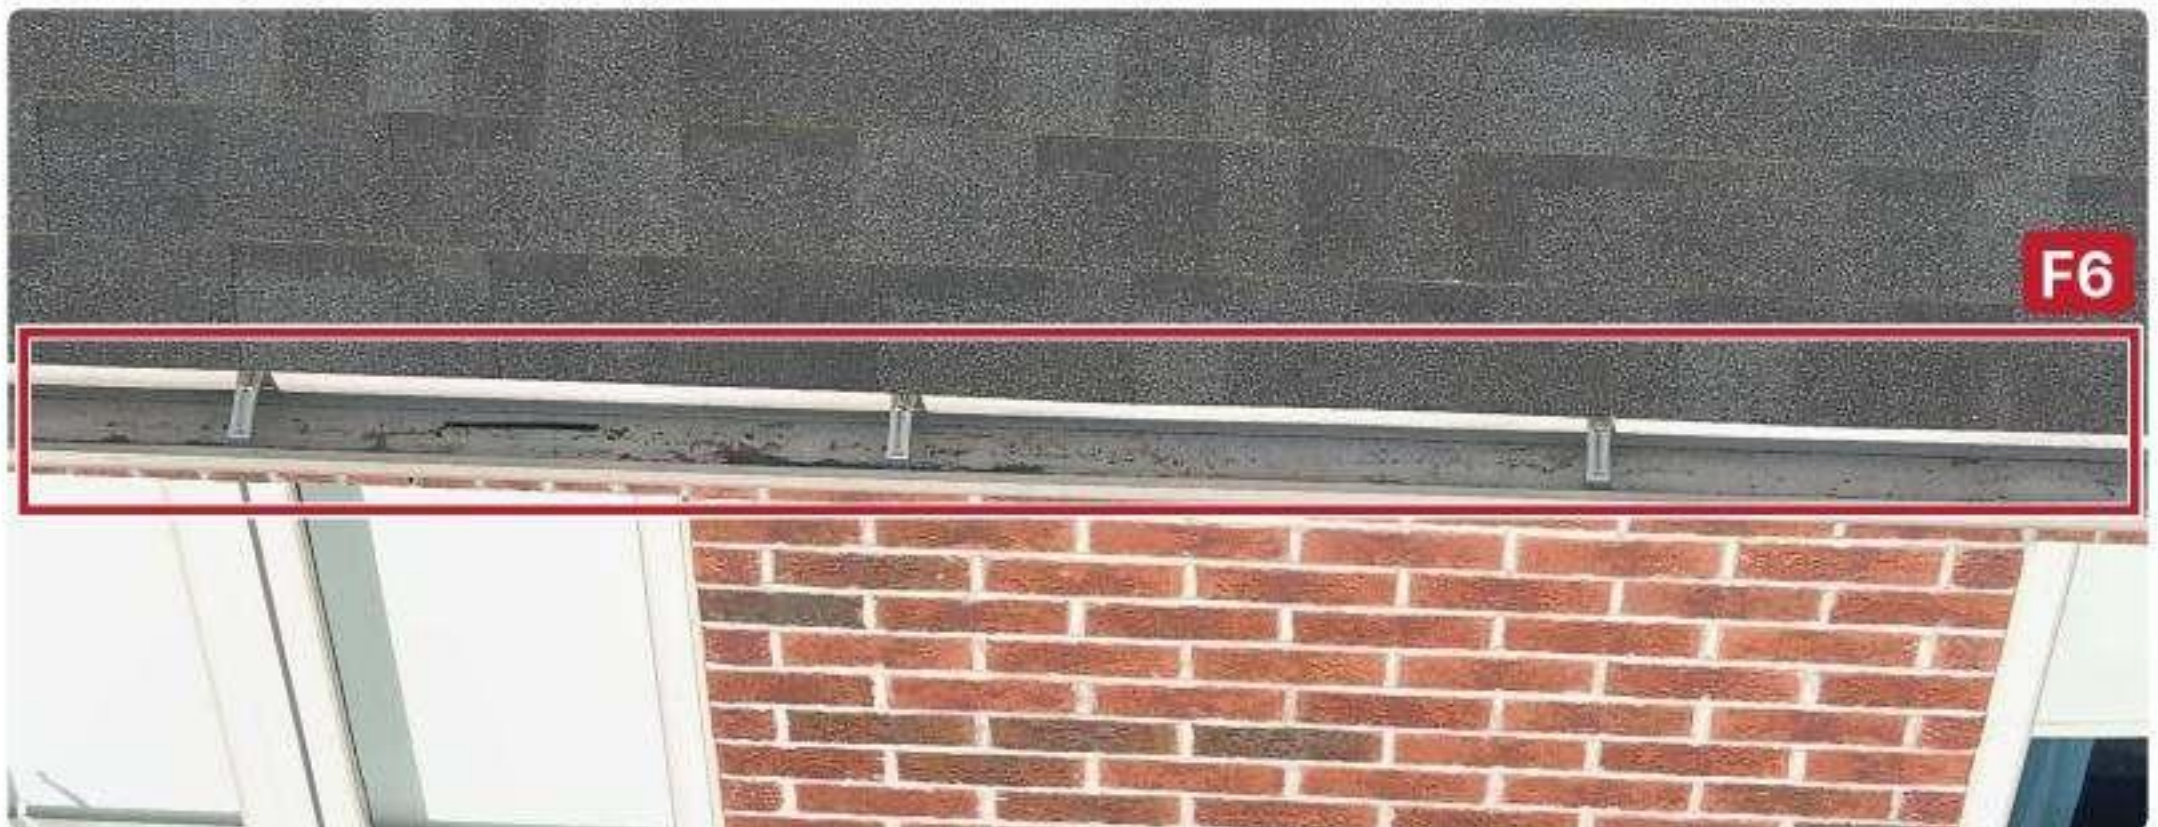
Photo 88

The rear eavestroughs contain sediment, shingle granules and organic debris, with dark staining along the trough. Small dormer gutters on the front slope also show debris.

Blocked gutters overflow onto the brick and foundation, and in winter can cause ice damming at the eaves, forcing water back under the shingles.

F6.1 – Sediment and debris in the rear eavestrough.

Clean and flush all eavestroughs and downspouts, confirm downspouts are discharging away from the building, and repeat cleaning each spring and fall.

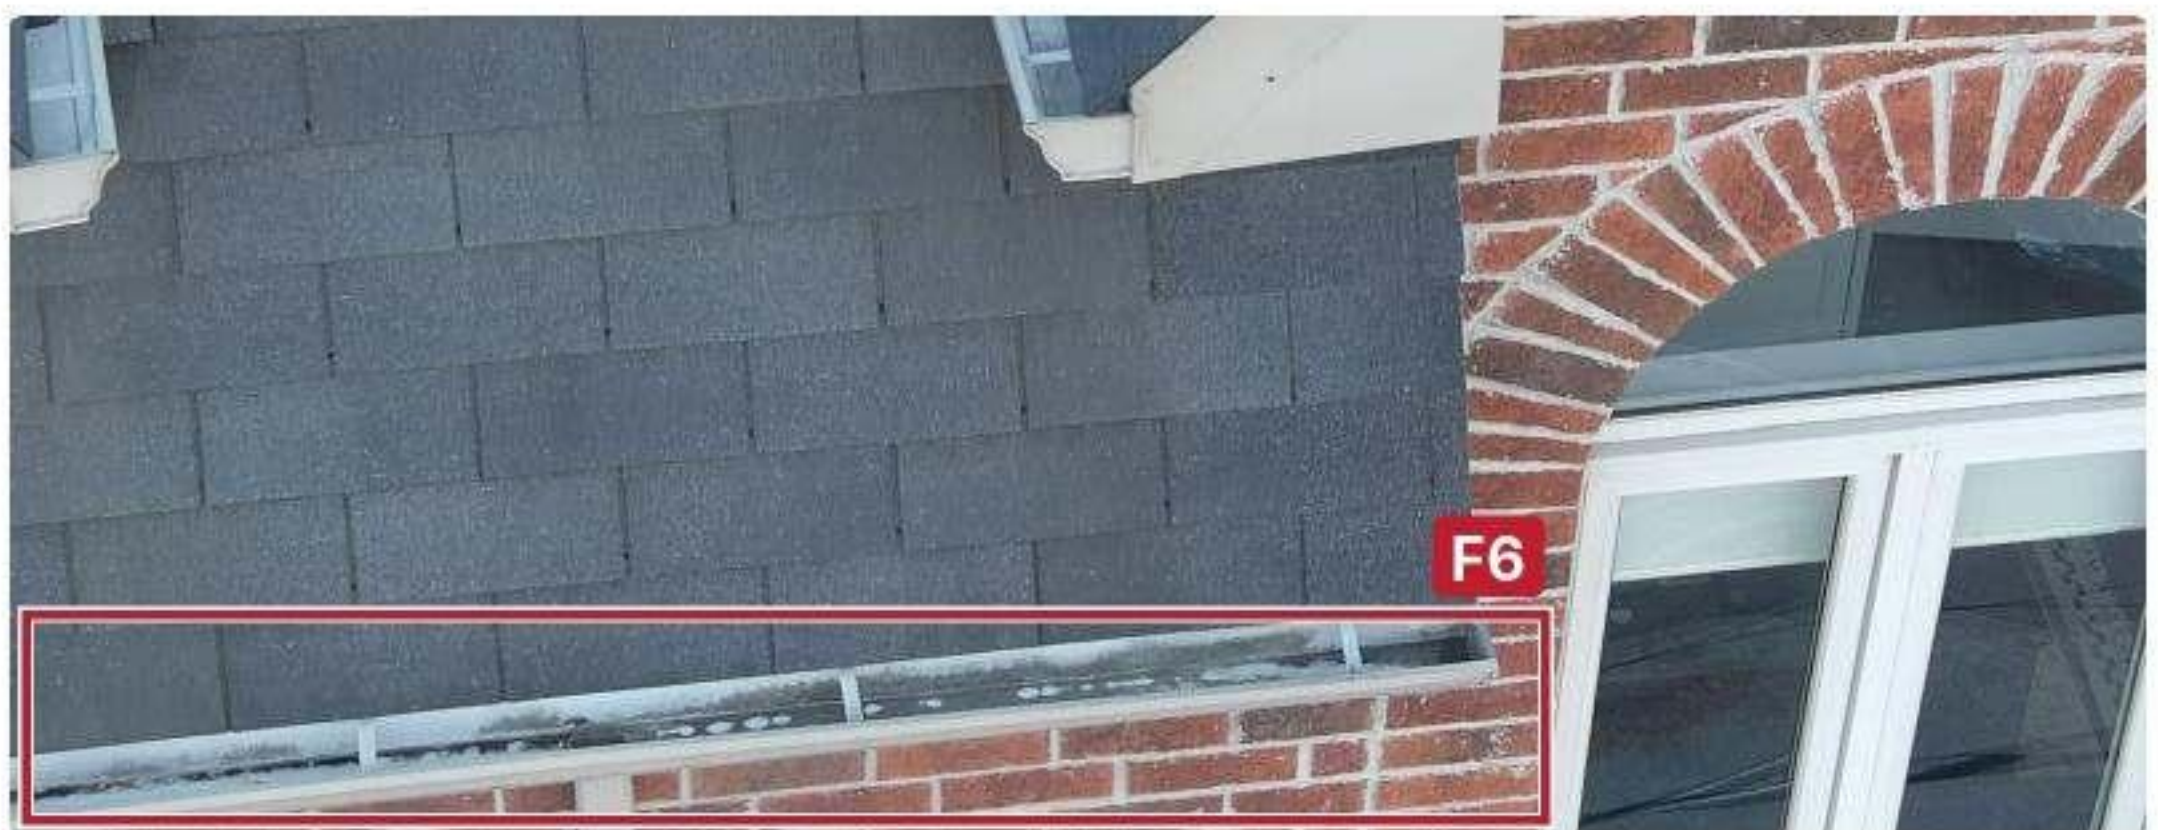
Photo 14

F6.2 – Debris in a dormer-level gutter.
