**Sample Property**

Greater Toronto Area, ON

SAMPLE REPORT · CLIENT DETAILS REMOVED

## Aerial Roof Inspection Report

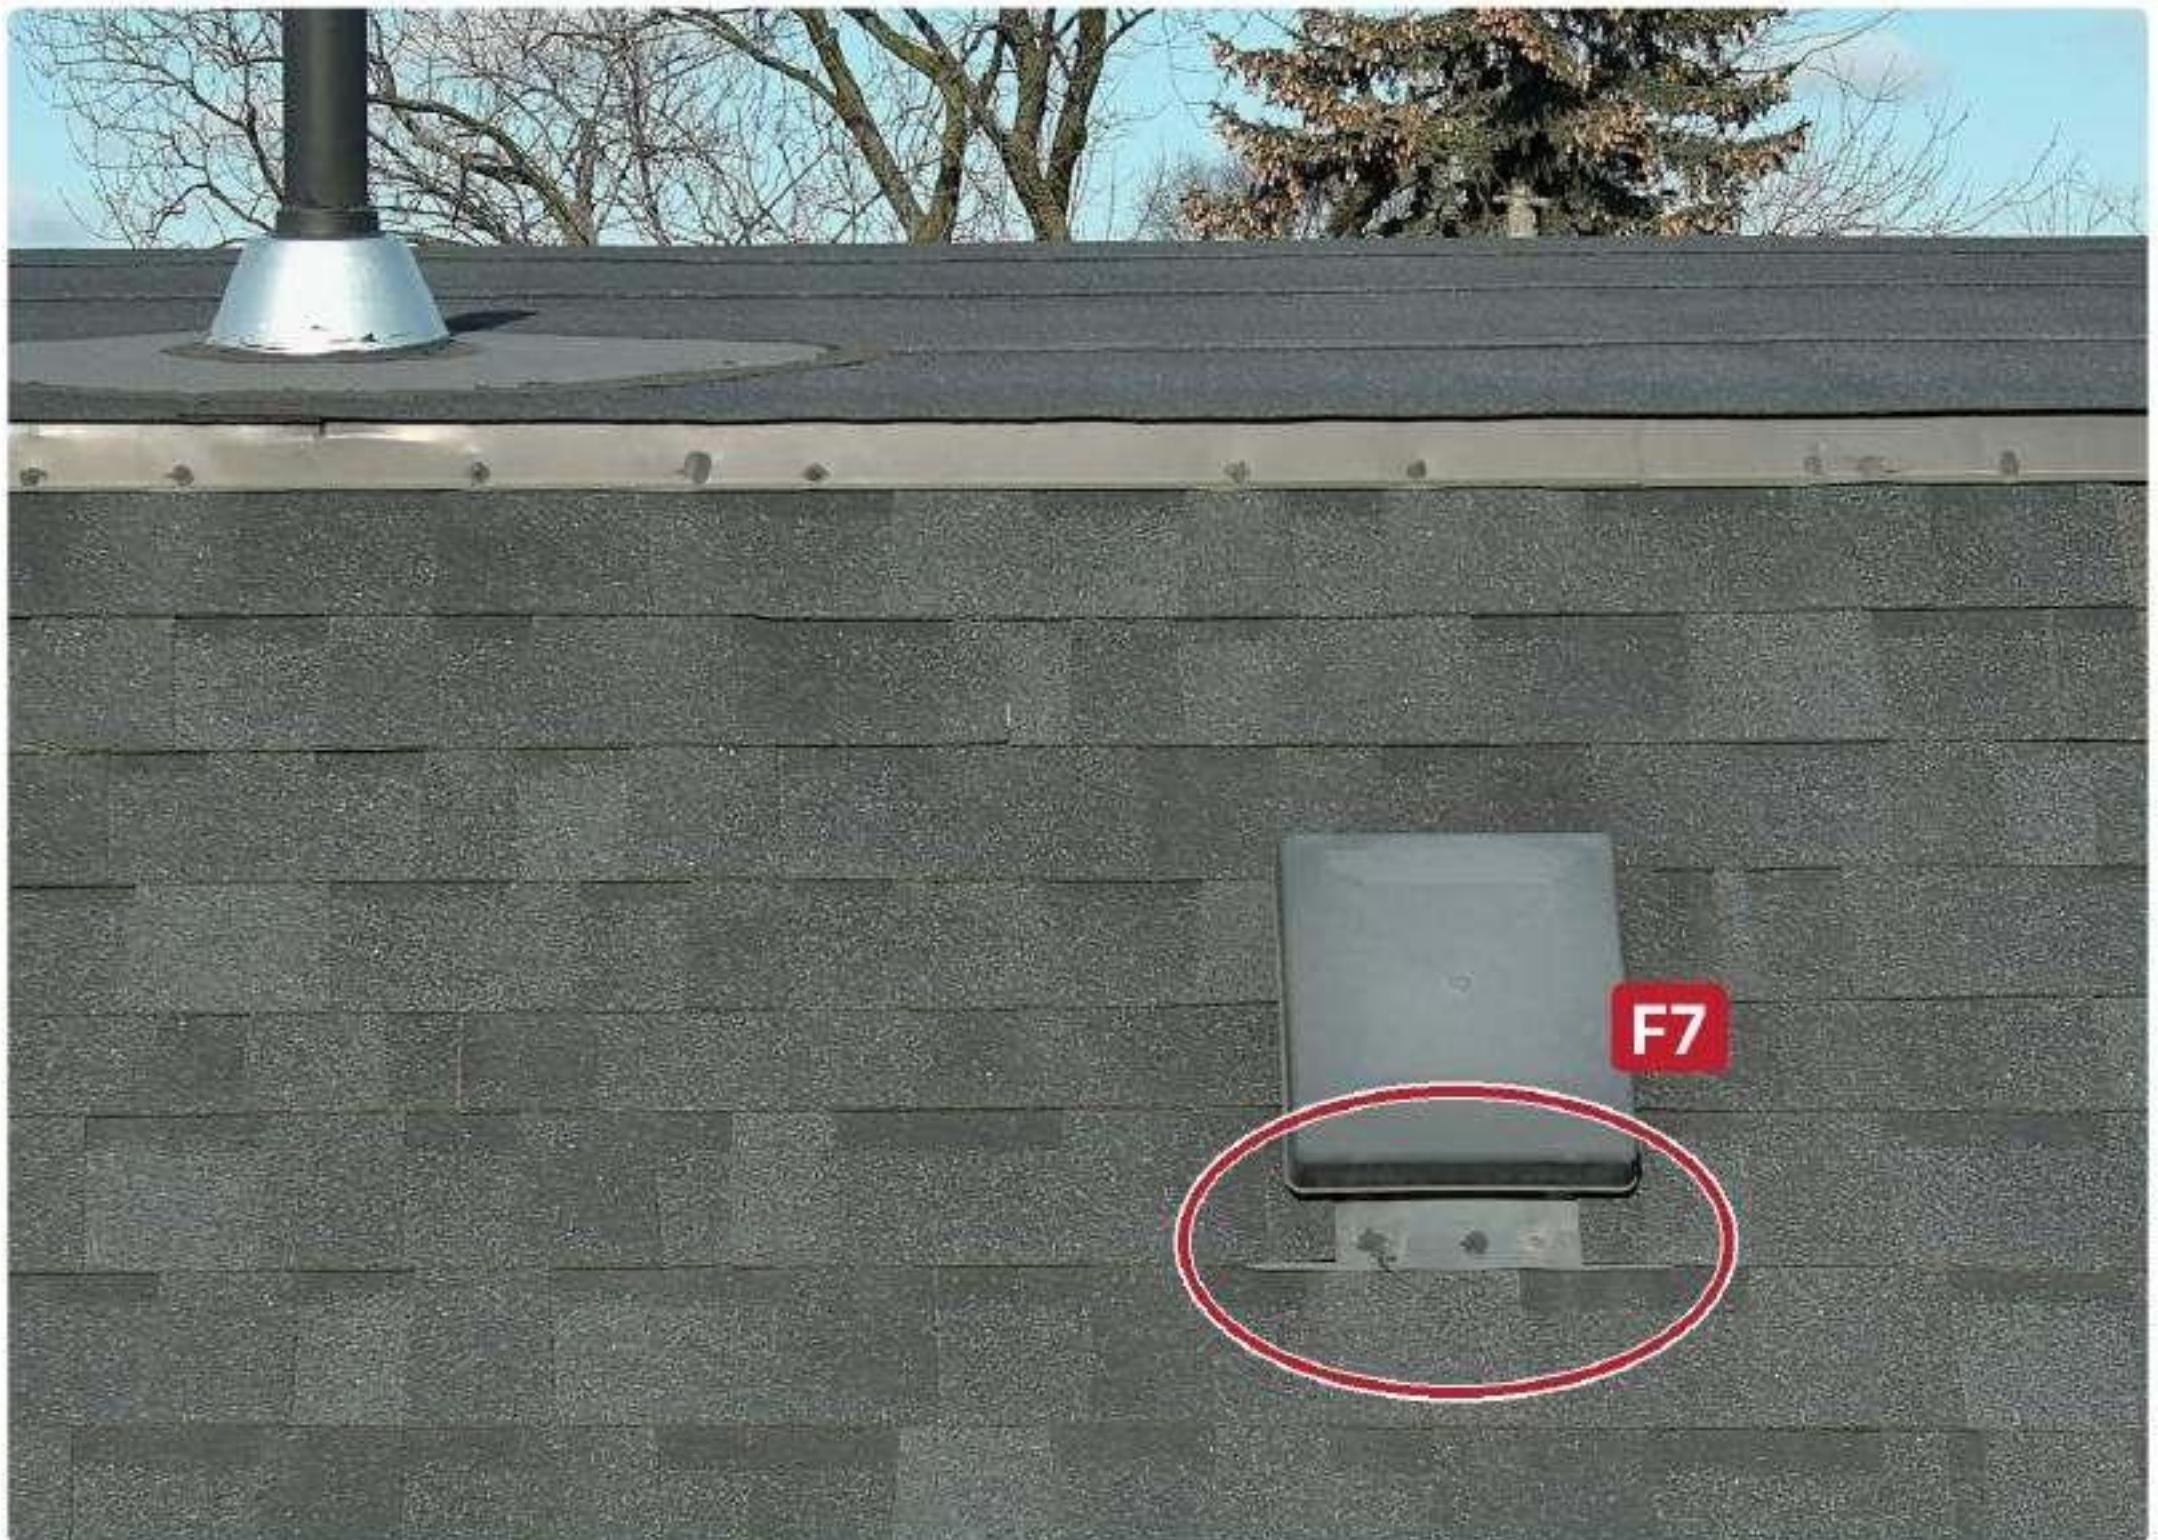
Photo 122

The lower flanges of several box vents are fastened through the face with sealant dabs over the fasteners. The vents themselves appear intact and undamaged.

Low risk at present, but exposed fasteners on vent flanges can leak once the sealant ages.

**F7.1** – Face-fastened lower flange on a box vent.

Re-seal exposed vent flange fasteners during routine maintenance.

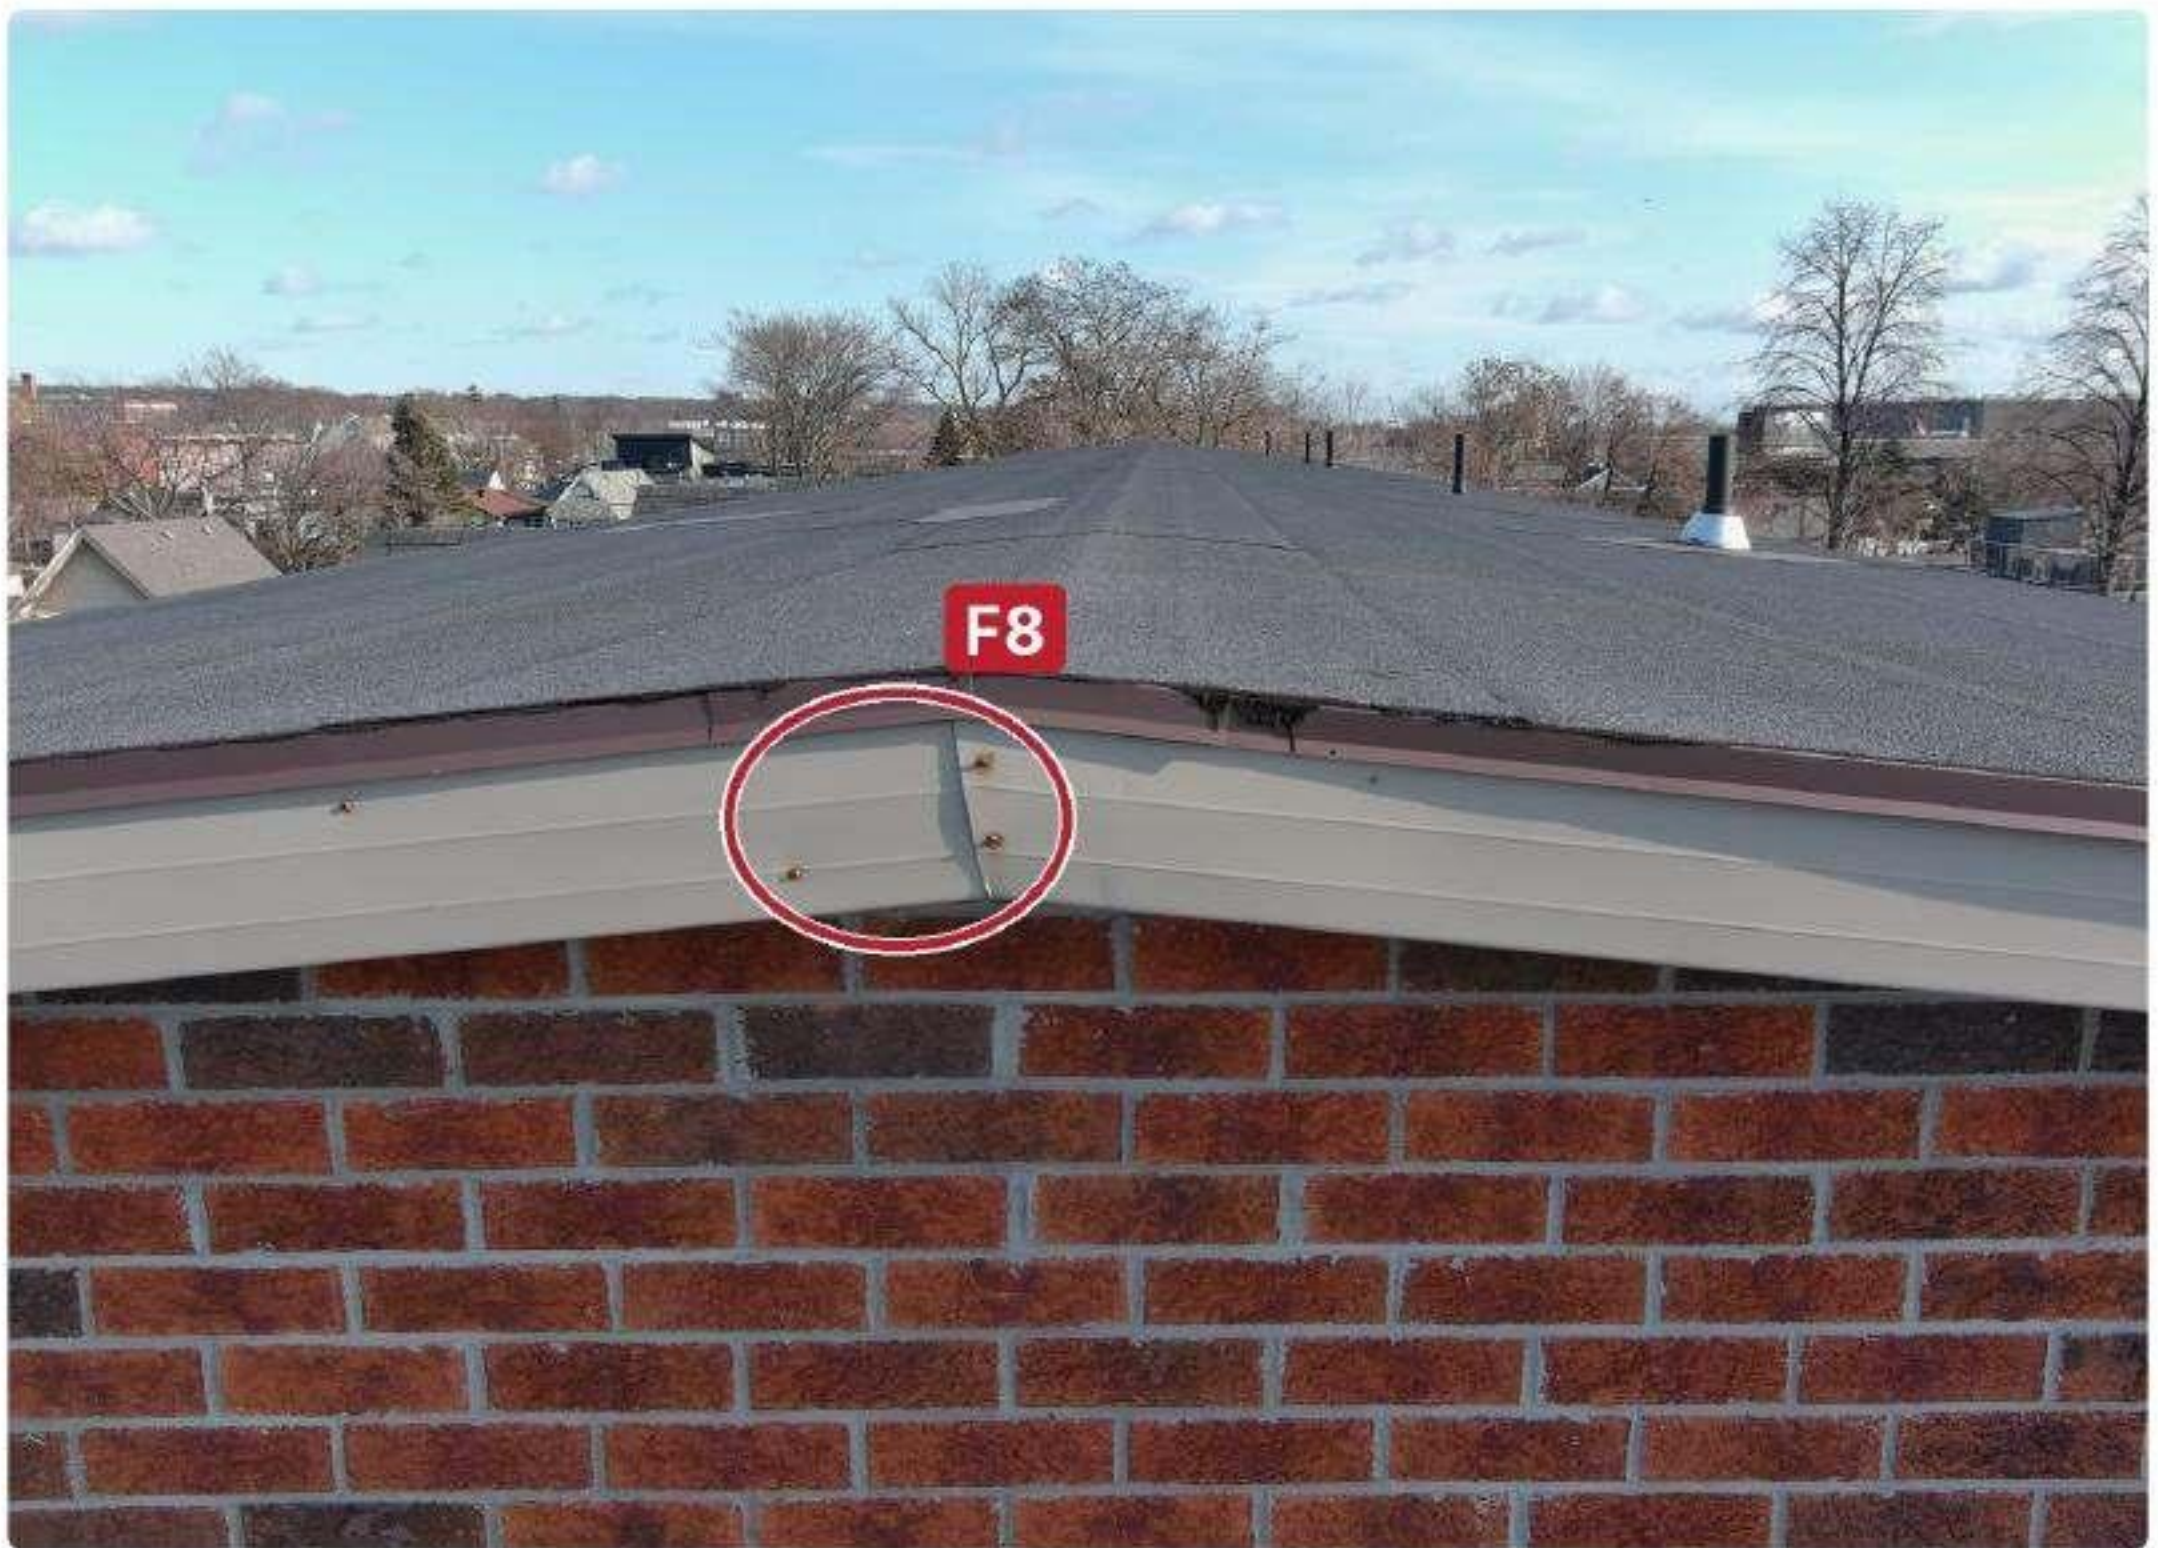
Photo 102

Rust-coloured staining is visible at several exposed screw heads on the pre-finished metal trim.

Mainly cosmetic, but corroding fasteners can loosen over time and allow trim to lift in high winds.

**F8.1** – Rust-stained screw heads on the gable-end trim.

Replace corroded screws with stainless or colour-matched coated fasteners when other repairs are carried out.

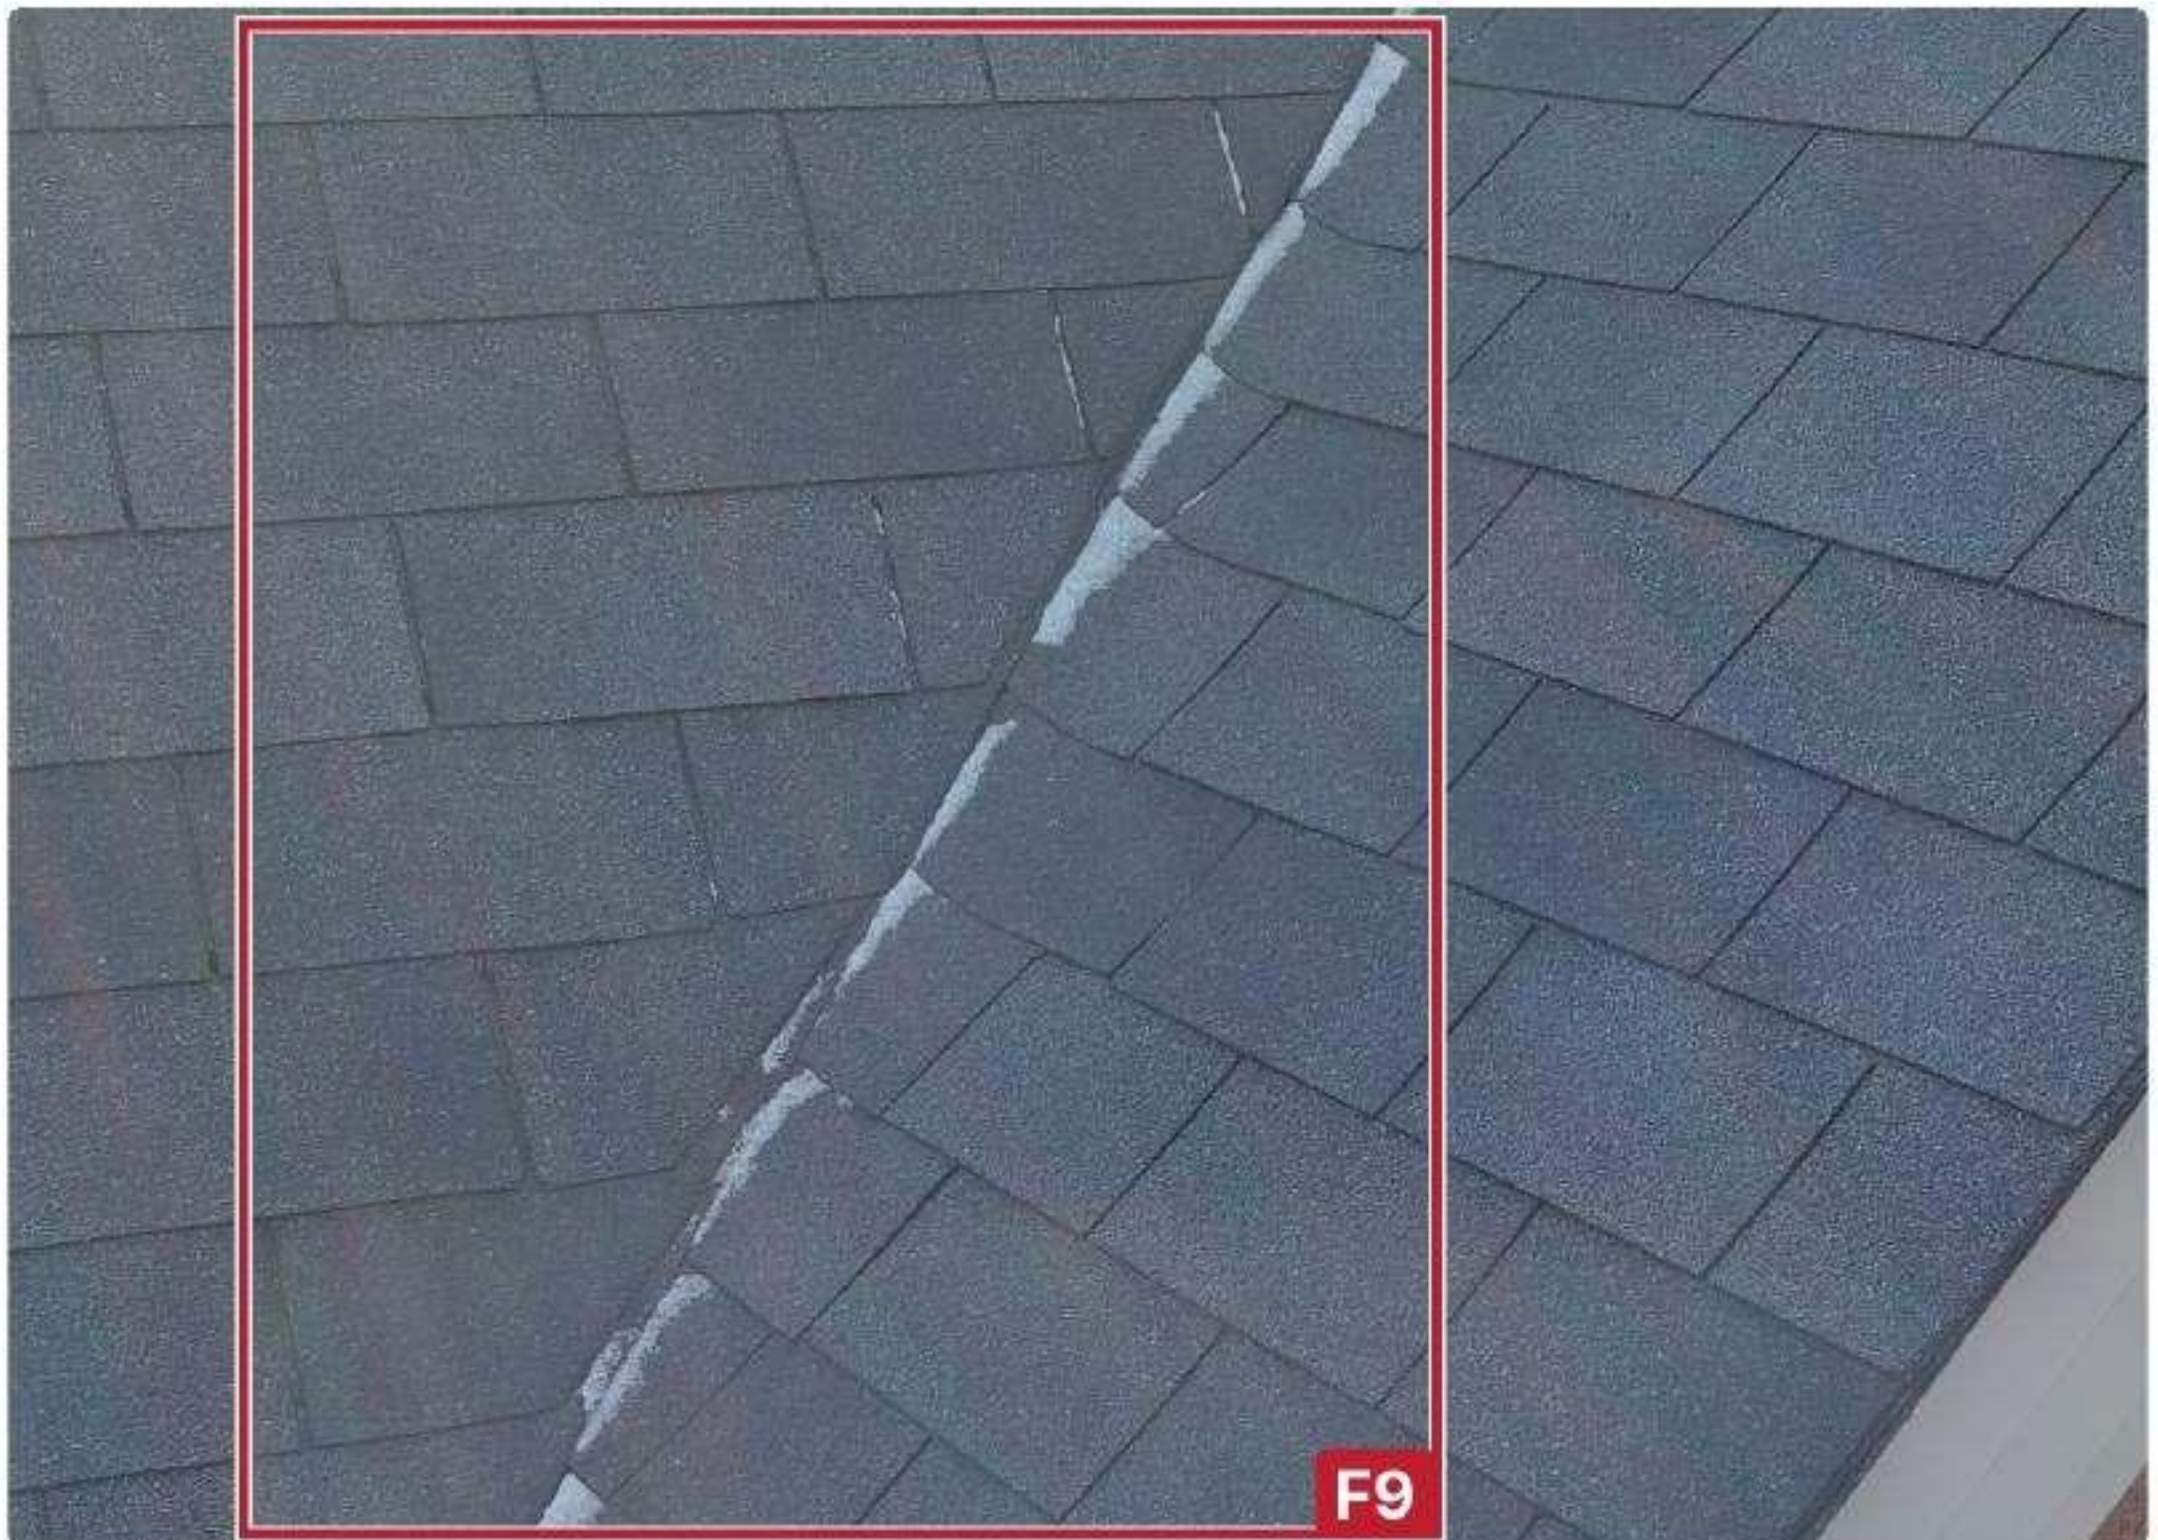
Photo 30

Light deposits are visible along the cut edges of the closed-cut valleys beside each dormer. Given the winter flight date, these are most likely residual frost or snow, but this could not be confirmed from the imagery.

If the deposits are frost/snow, there is no concern. If they are sealant or areas of granule loss, the valleys should be checked, as valleys carry concentrated water flow.

F9.1 – Light deposits along the valley cut line.

Confirm the condition of the valleys during the next on-roof visit or follow-up flight in clear, snow-free conditions.
