**Sample Site**  
Greater Toronto Area, ON

SAMPLE REPORT · CLIENT DETAILS REMOVED

# Aerial Site Survey & Mapping Report

Orthomosaic, elevation models, contours, 3D point cloud and mesh, stockpile volumes and a repeat-survey baseline, all produced from a single drone mapping flight.

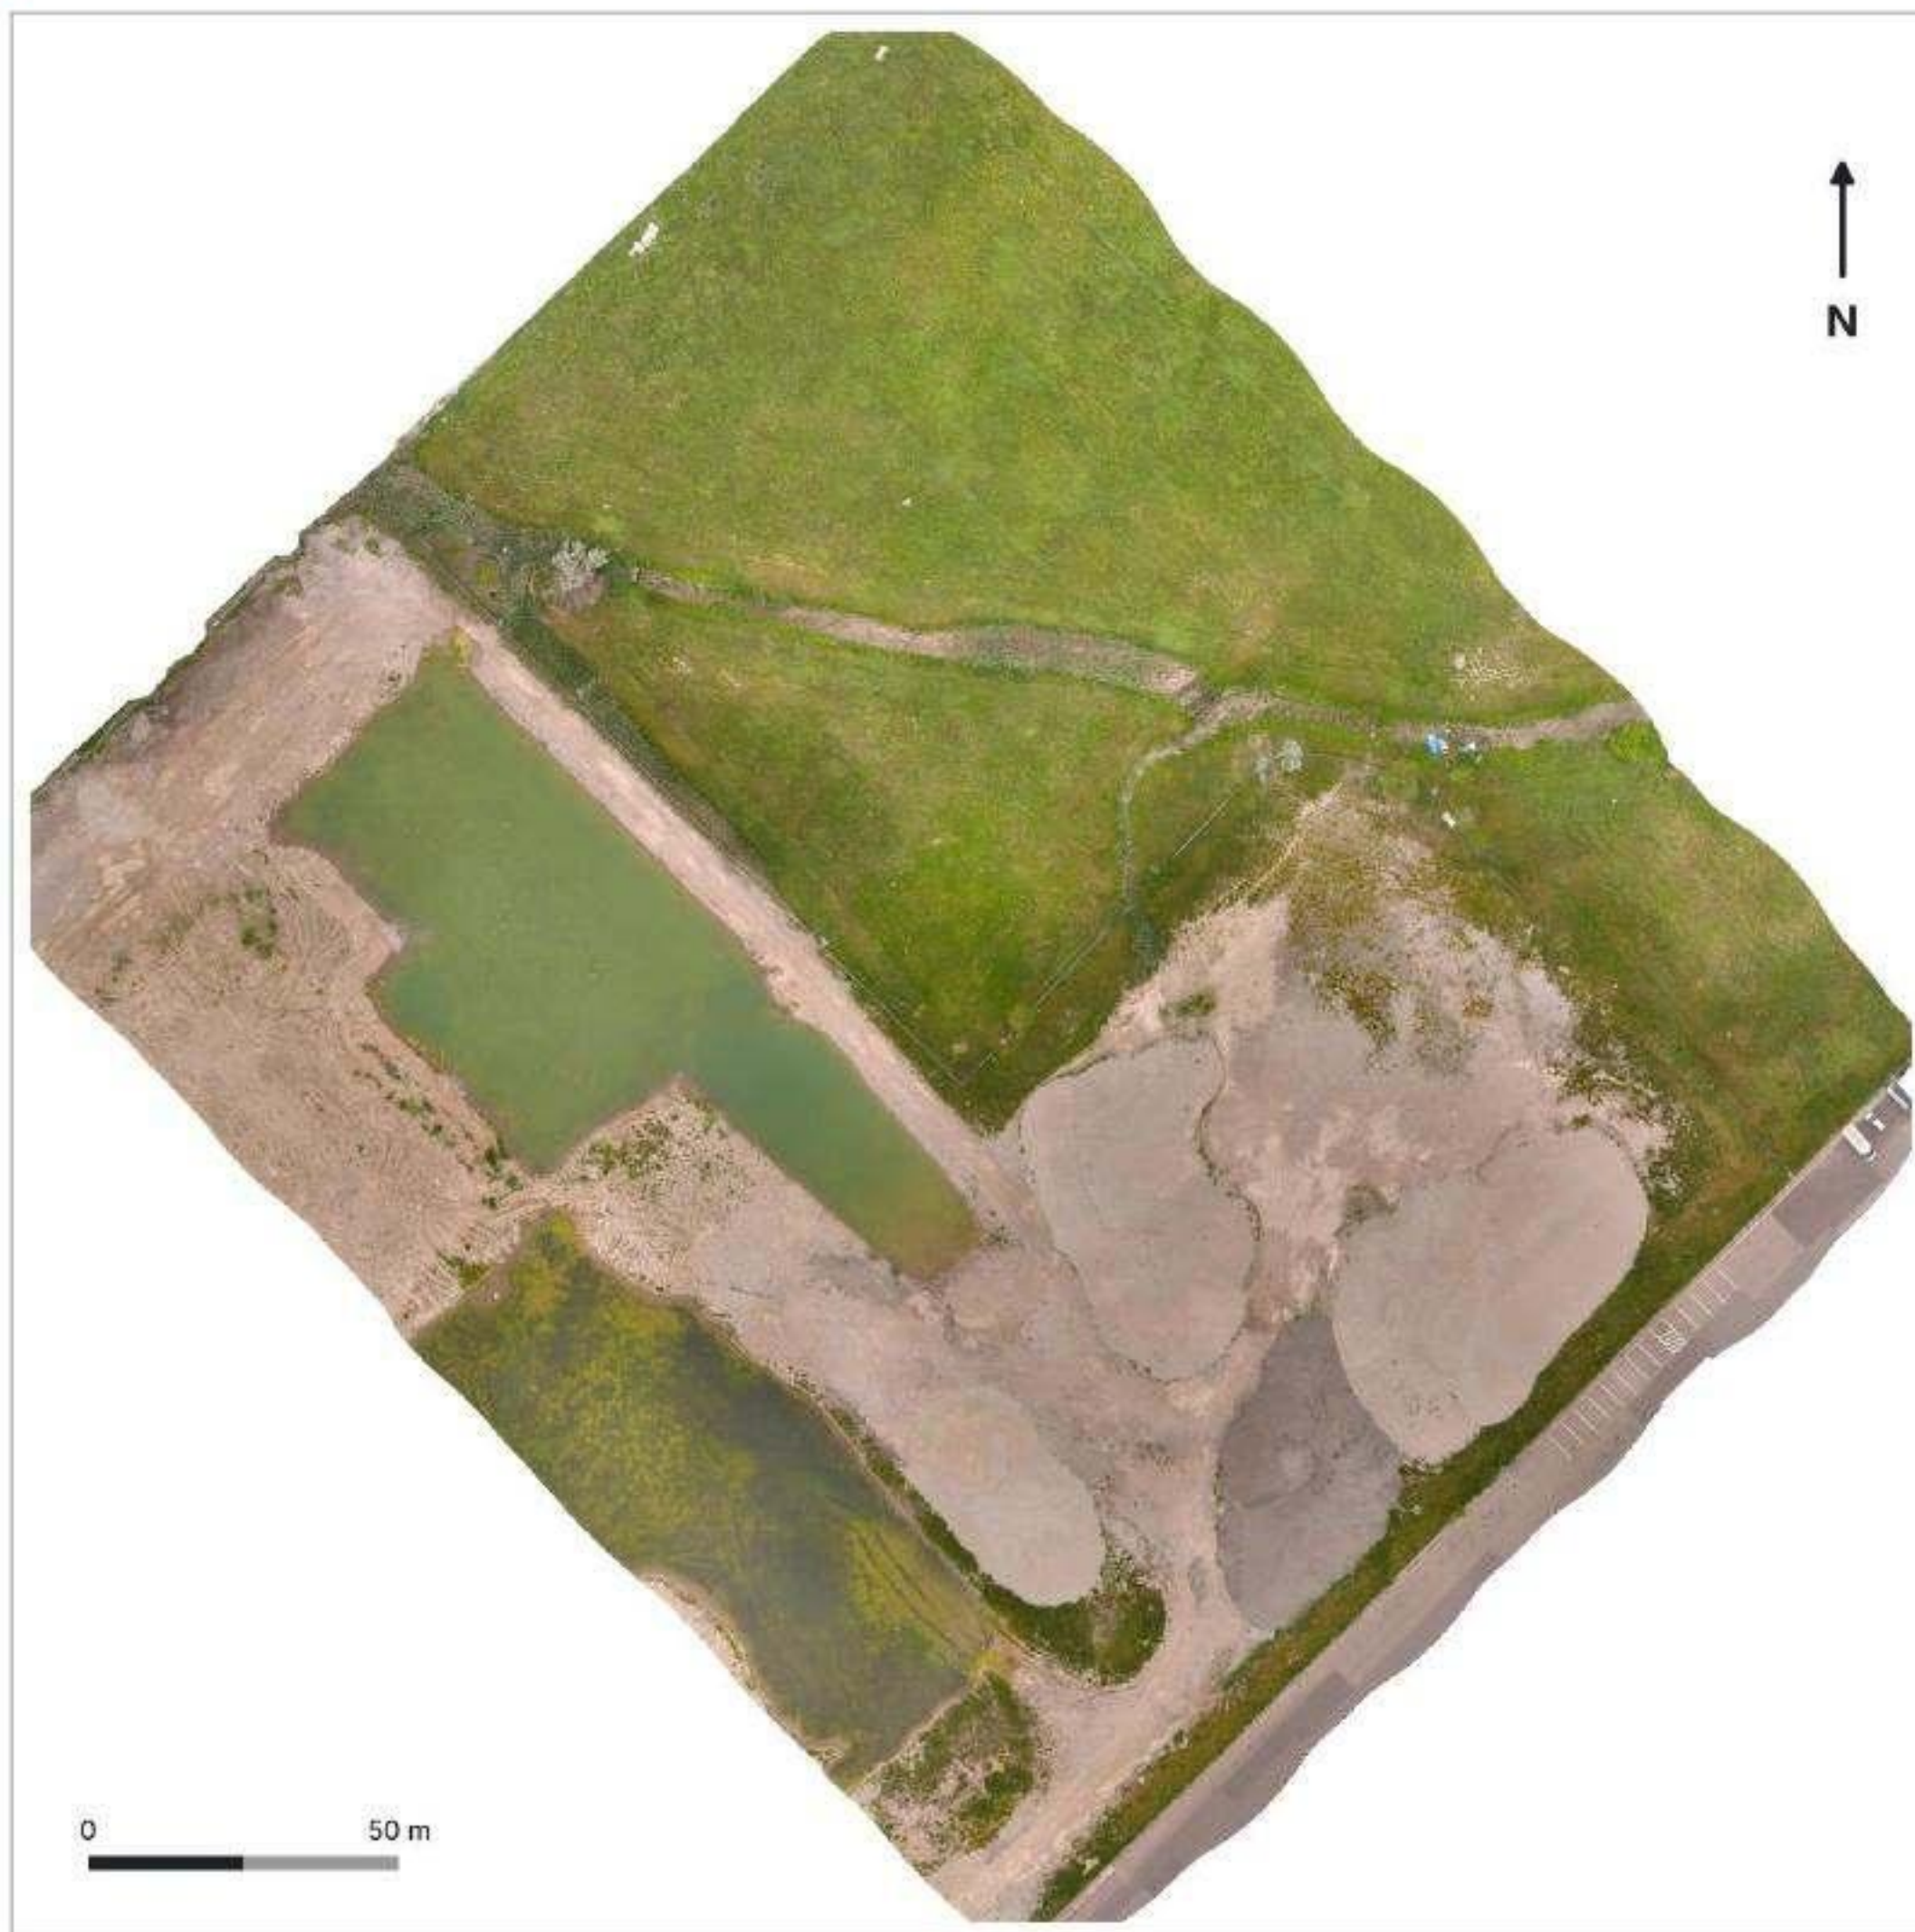
**Figure 3.1** - True orthomosaic, 3 cm ground pixel, 5.8 ha.

Each ground cell is taken from the most straight-down view available and blended across seams. Water surfaces and the far edges of the flight have the lowest image quality.

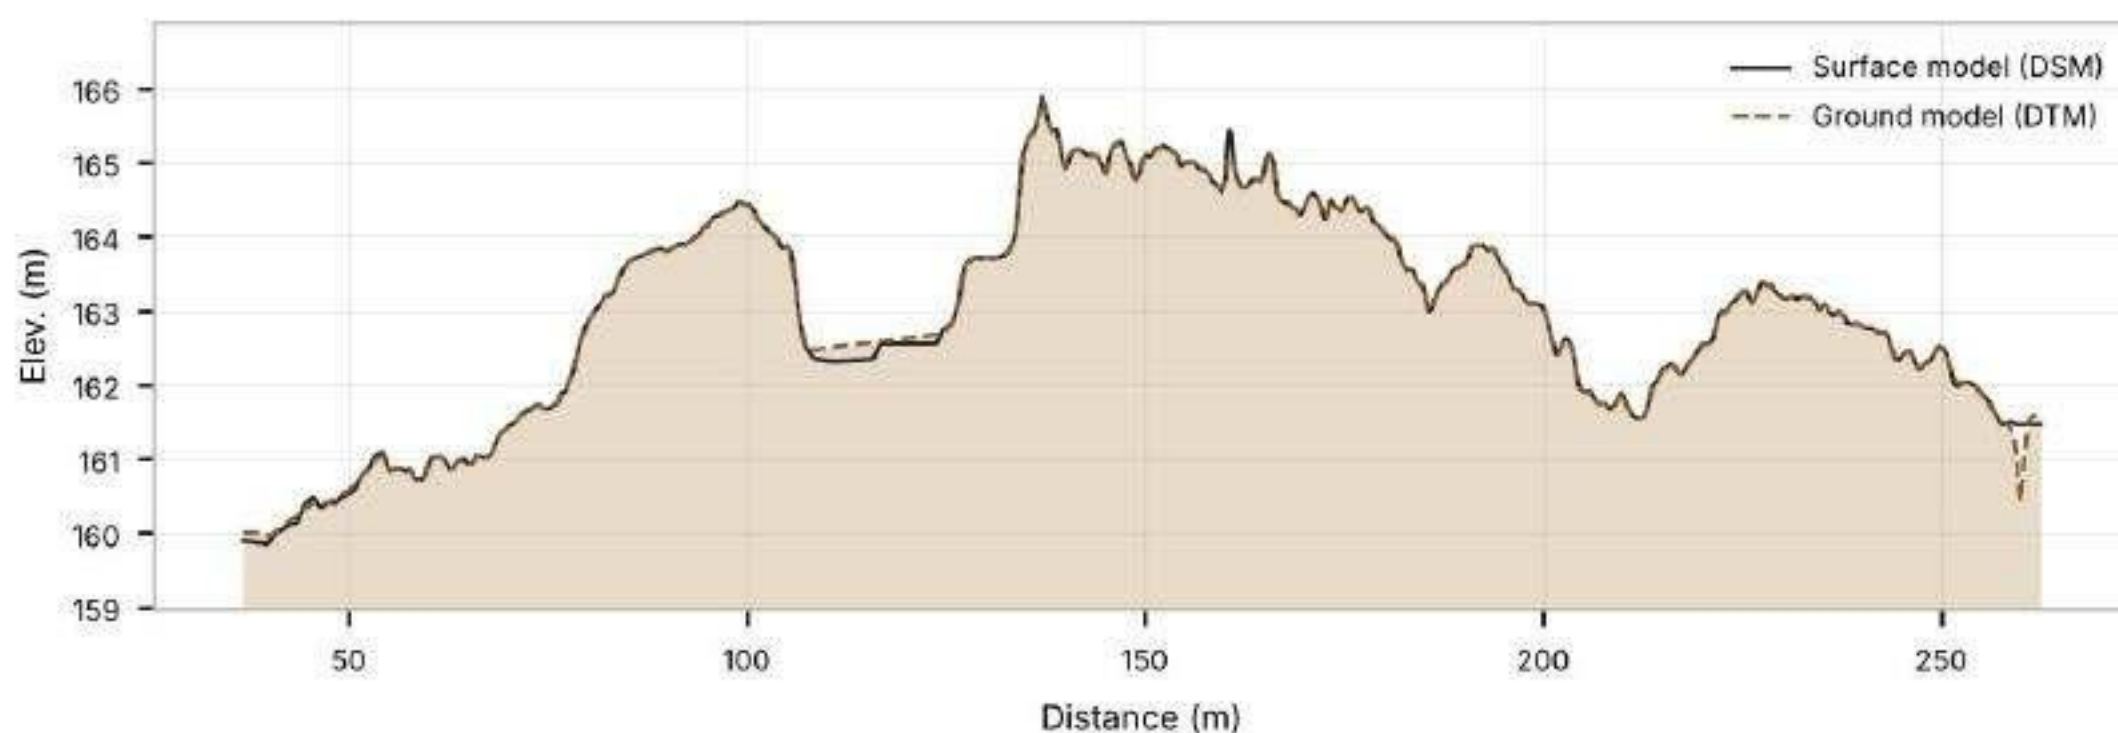
**Figure 4.3** · North-west to south-east cross-section through the site, DSM vs DTM

Vertical exaggeration ≈ 5×

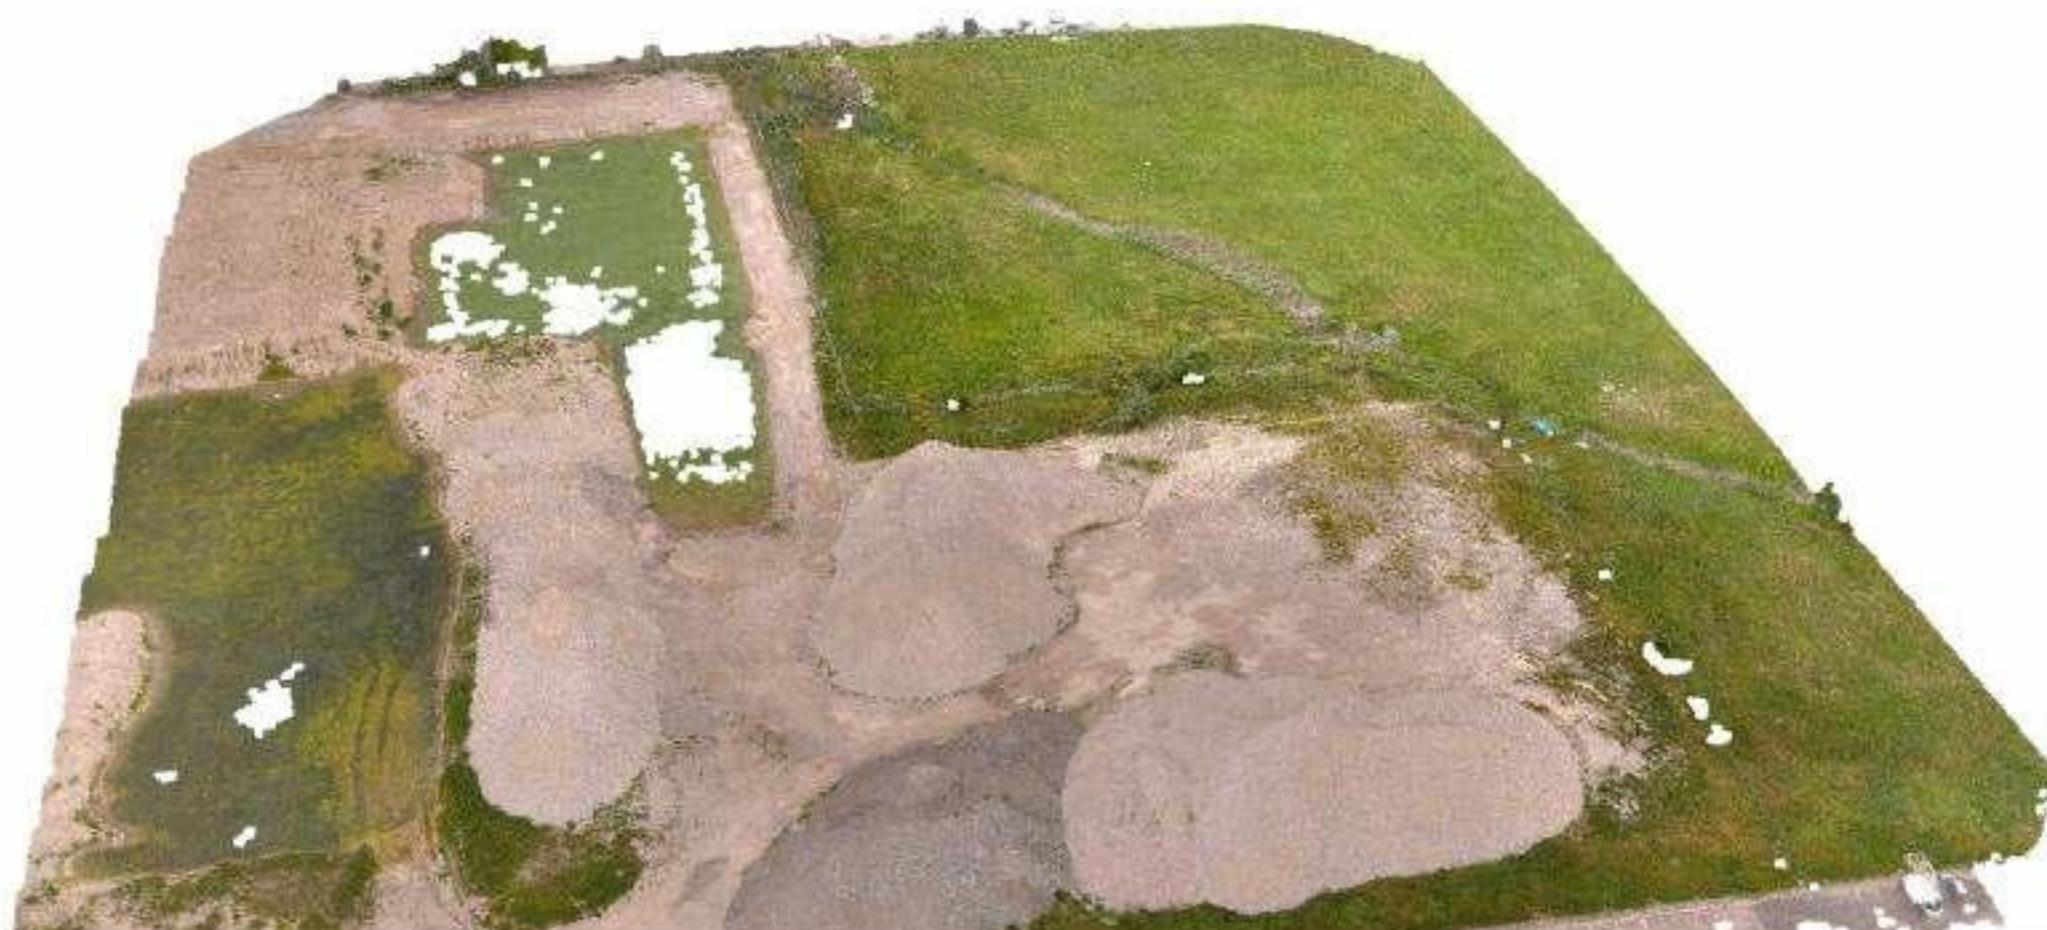
**Figure 5.1** · Oblique view of the coloured dense point cloud, looking north

Gaps = open water (no texture to match)

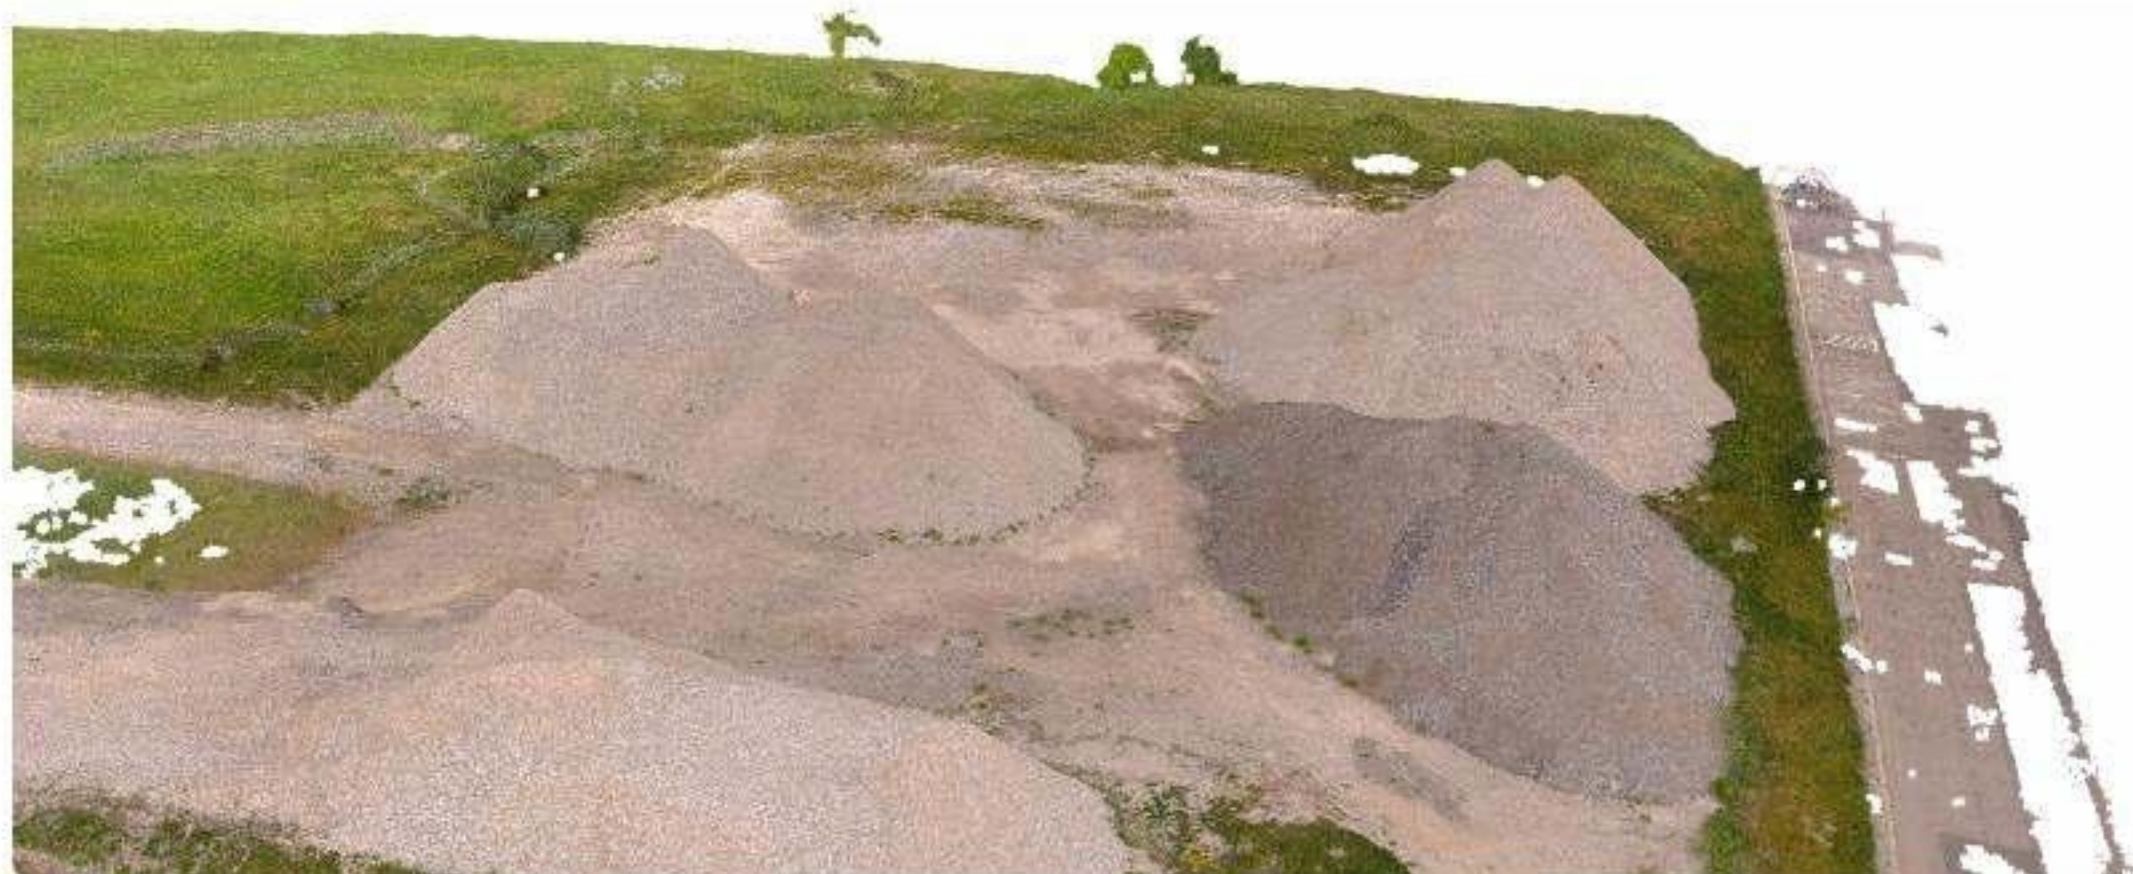
**Figure 5.2** · Stockpile area, close oblique view

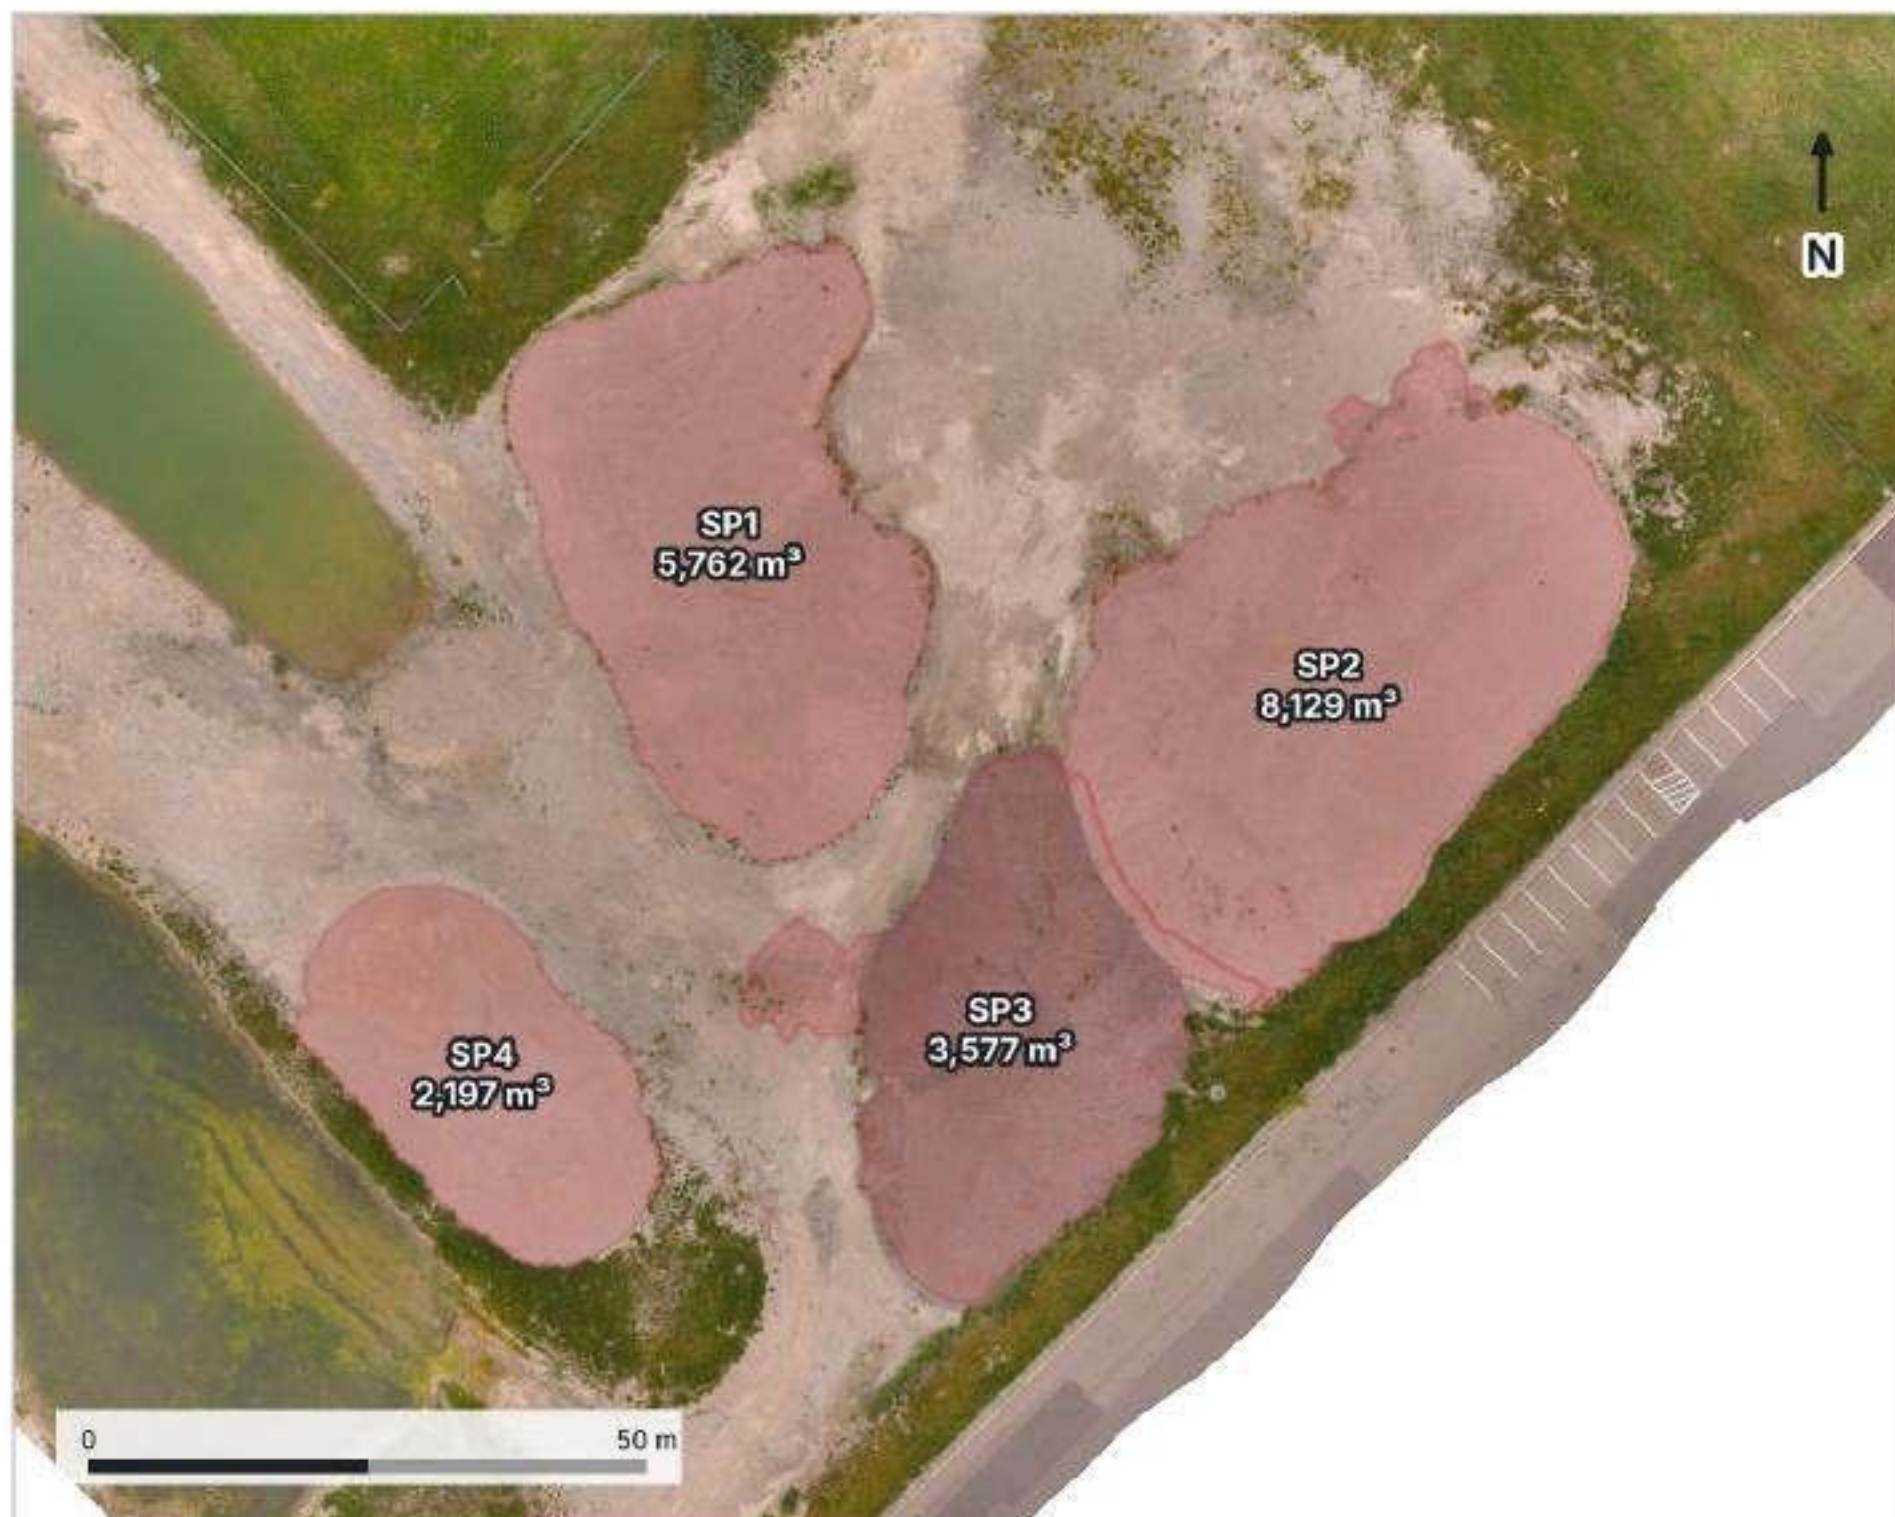
Figure 6.1 · Stockpile footprints and measured volumes

Base: best-fit toe plane

**Method.** Each pile's toe was traced from the 10 cm DSM, and the base surface is a plane fitted robustly to a ring of ground 1–2 m outside the toe. Volume is the DSM above that base. Uncertainty = footprint × the standard deviation of the ground ring about the plane. Tonnage uses an assumed bulk density of 1.7 t/m<sup>3</sup> for loose granular material; replace it with the supplier's density for billing. Material types are visual only.

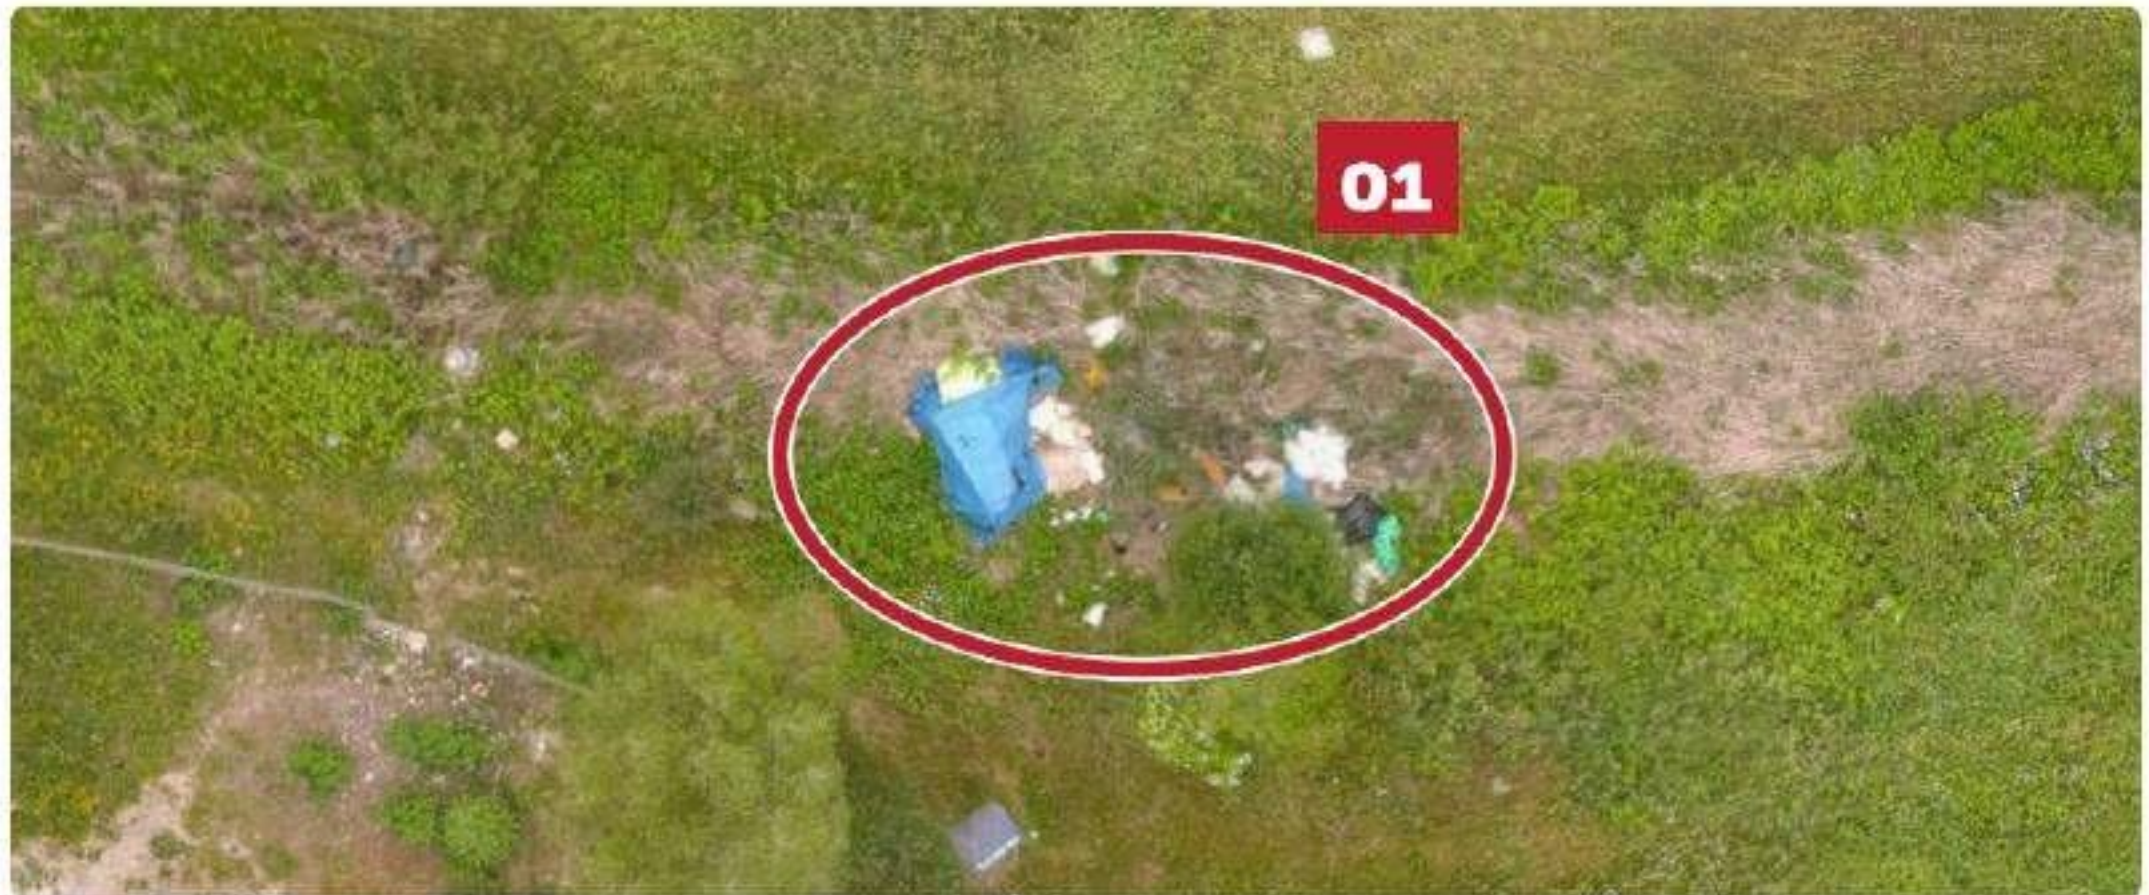
A blue tarp, bags, scattered refuse and timber/pallet pieces lie in and beside the vegetated drainage swale that crosses the north field. A second cluster of debris sits along the north-west fence line, beside the north pond.

Debris in a drainage swale can block flow during storms and be washed toward the ponds and outlets. It also suggests unauthorised access or dumping, which carries liability and safety exposure for the owner.

01.1 – Tarp, bags and refuse in the north swale.

Remove and dispose of the debris, then check fencing and gates along the north limit for gaps. Add signage or secure the access if dumping continues.

**Timeframe:** Within 3 months

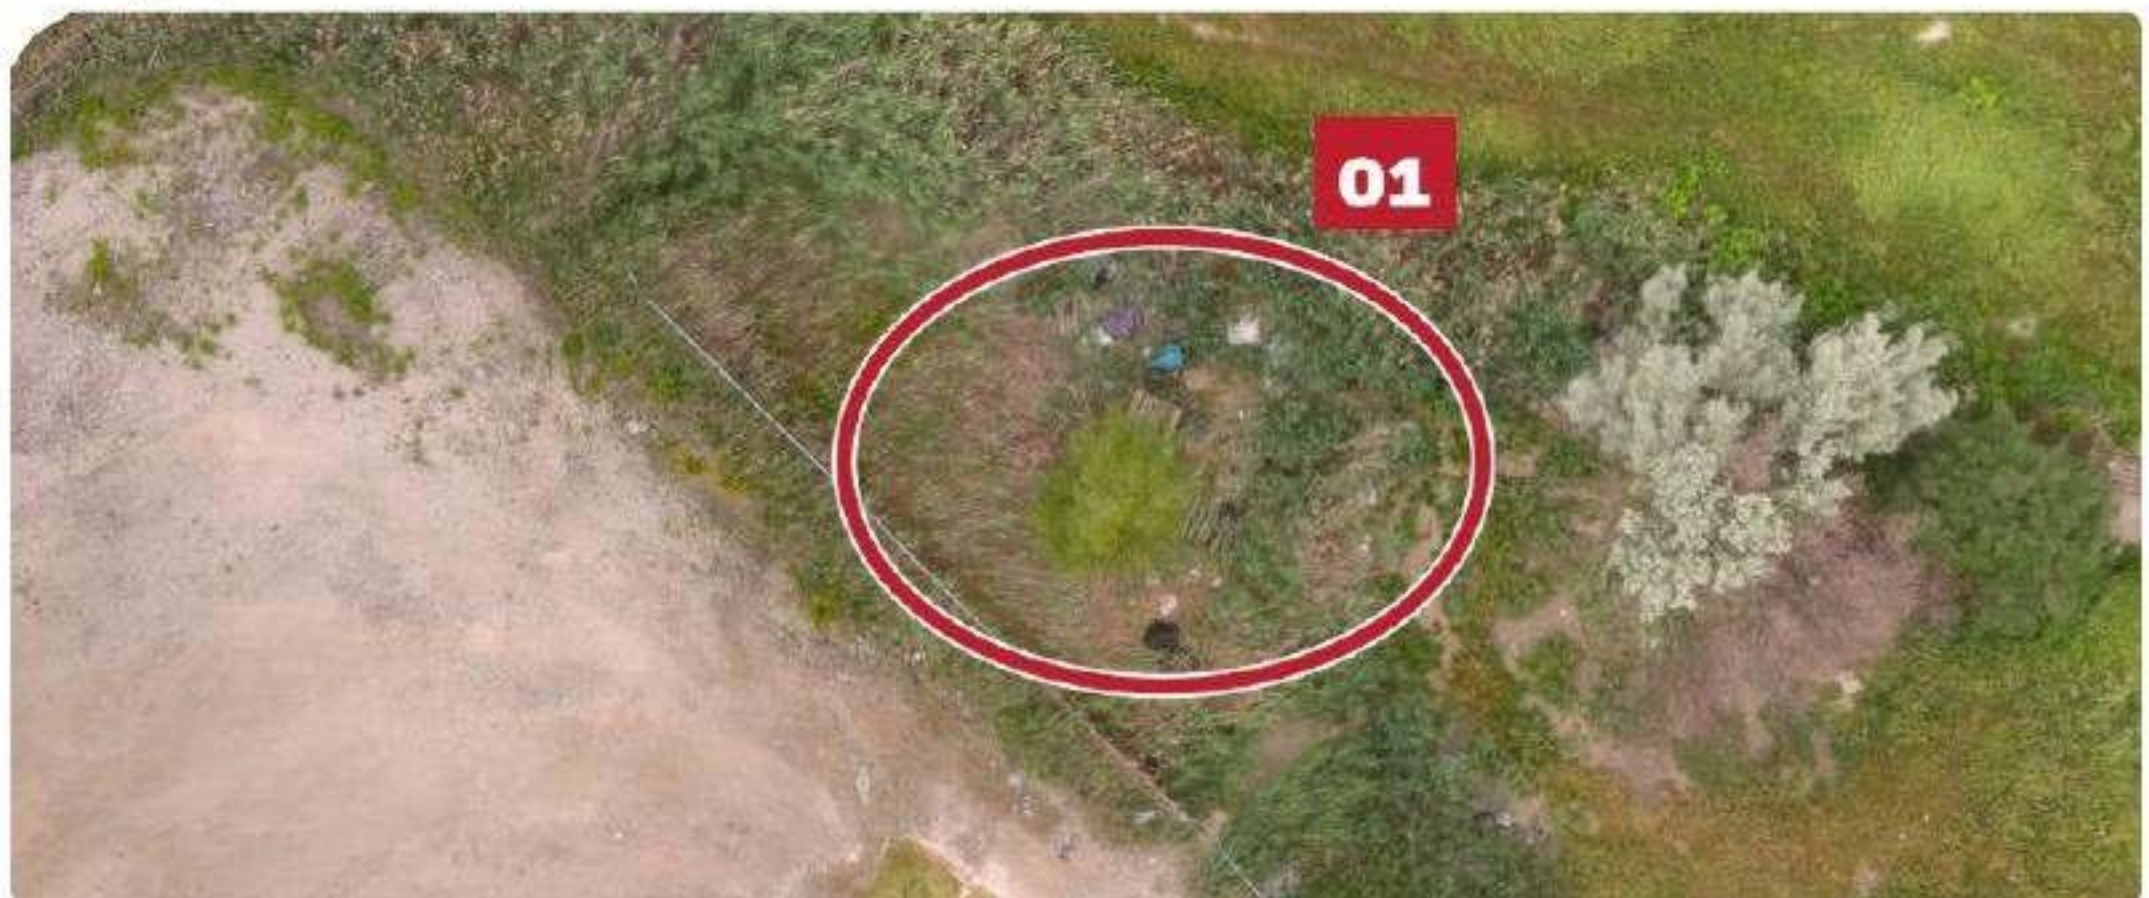
01.2 – Debris along the north-west fence line, beside the north pond.

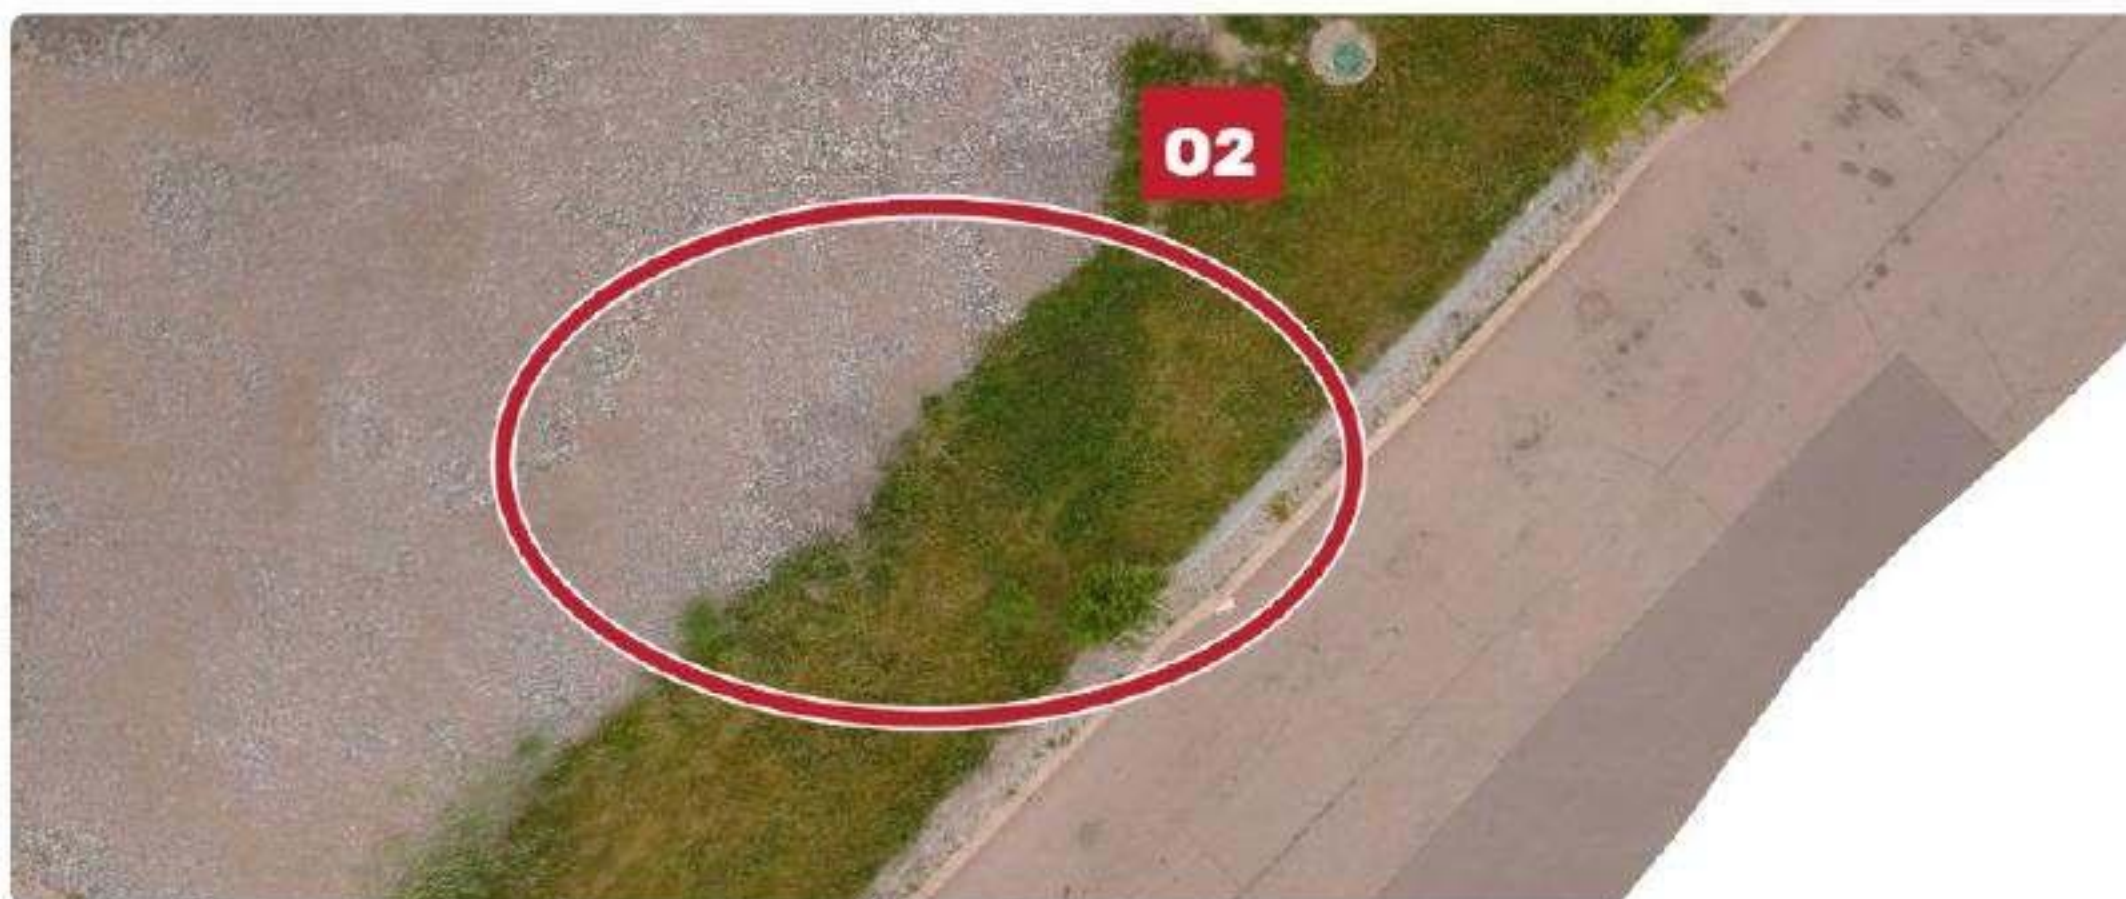
No silt fence, filter sock, perimeter berm or cover is visible around any of the four stockpiles. The toes of SP2 and SP3 sit about 11-12 m from the road curb, with only the grassed boulevard as a buffer.

Uncovered granular stockpiles shed fines in heavy rain. Sediment can reach the road and storm sewer. Municipal site-alteration and erosion and sediment control (ESC) permits typically require perimeter controls on stockpiles near a road.

02.1 – SP3 toe beside the grassed boulevard, with no perimeter control visible.

Install perimeter sediment control on the downslope (road and pond) sides of SP2, SP3 and SP4, and check it against the approved ESC plan. Stabilise or cover piles that will stay in place long-term.

**Timeframe:** Within 3 months / before the next storm season

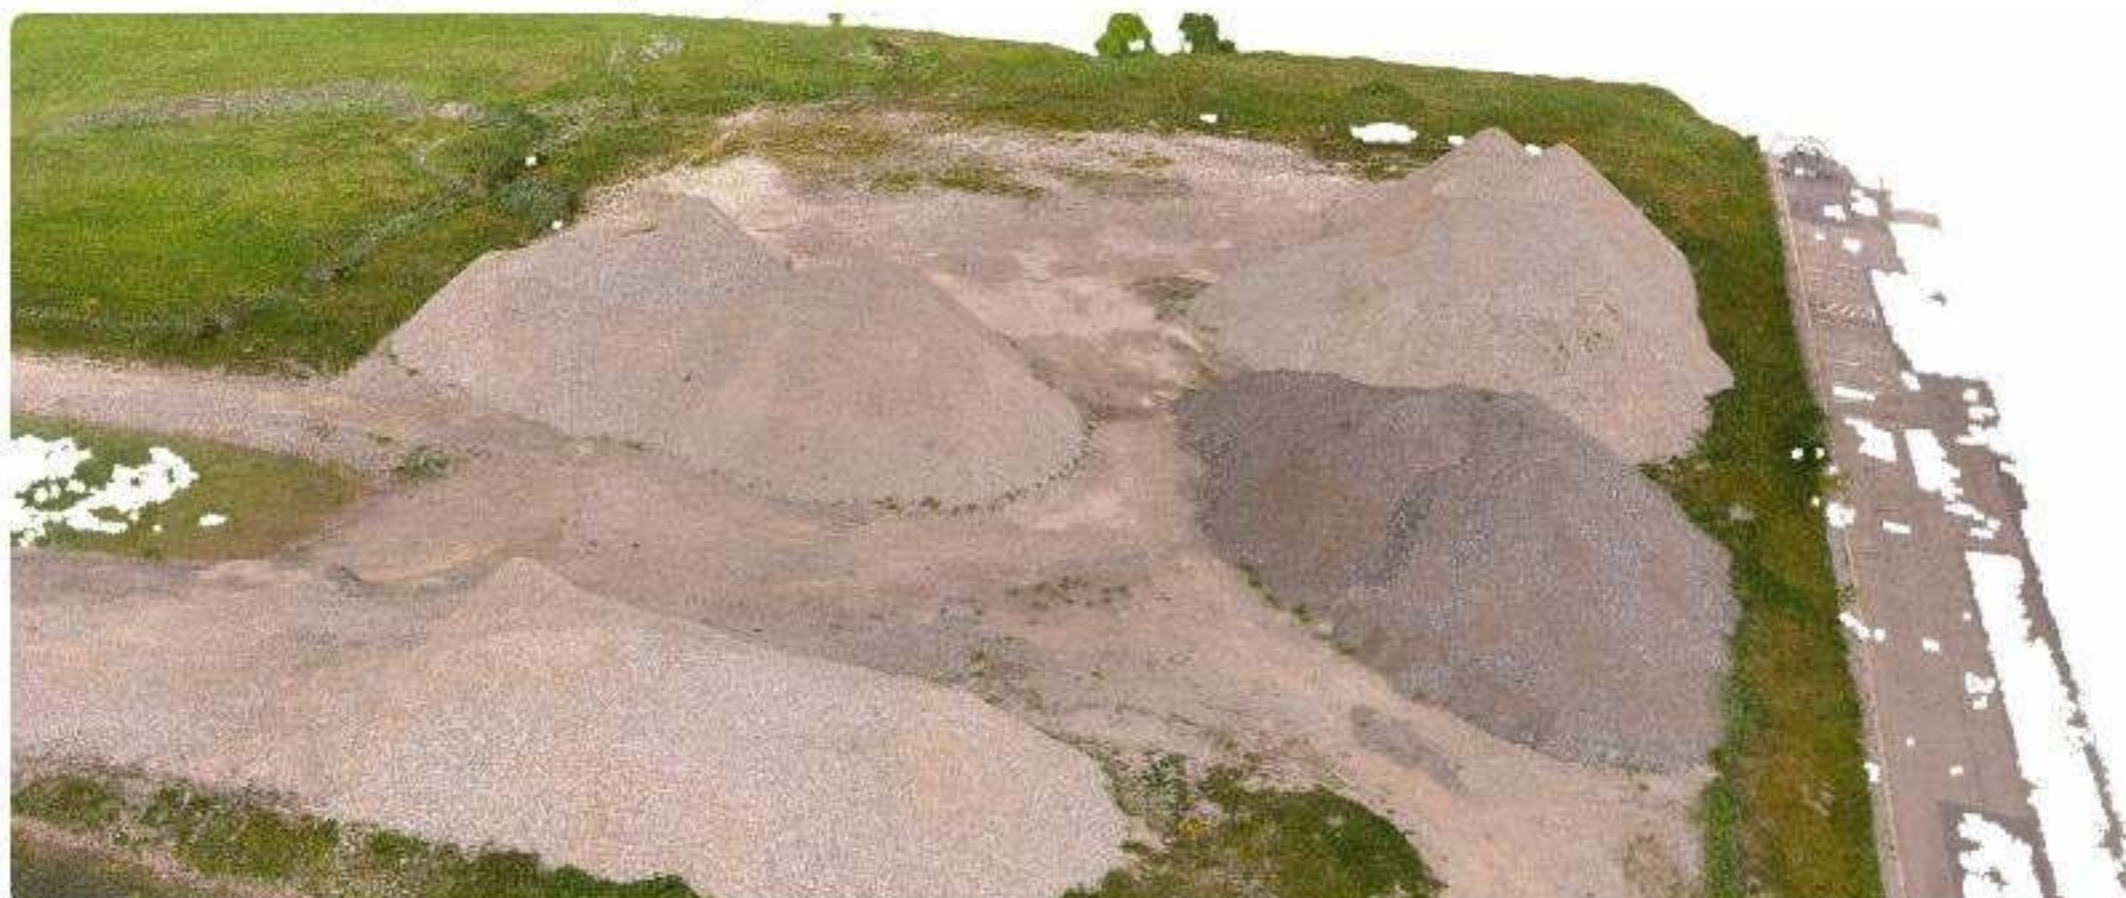
02.2 – 3D view of the stockpile area from the dense point cloud.

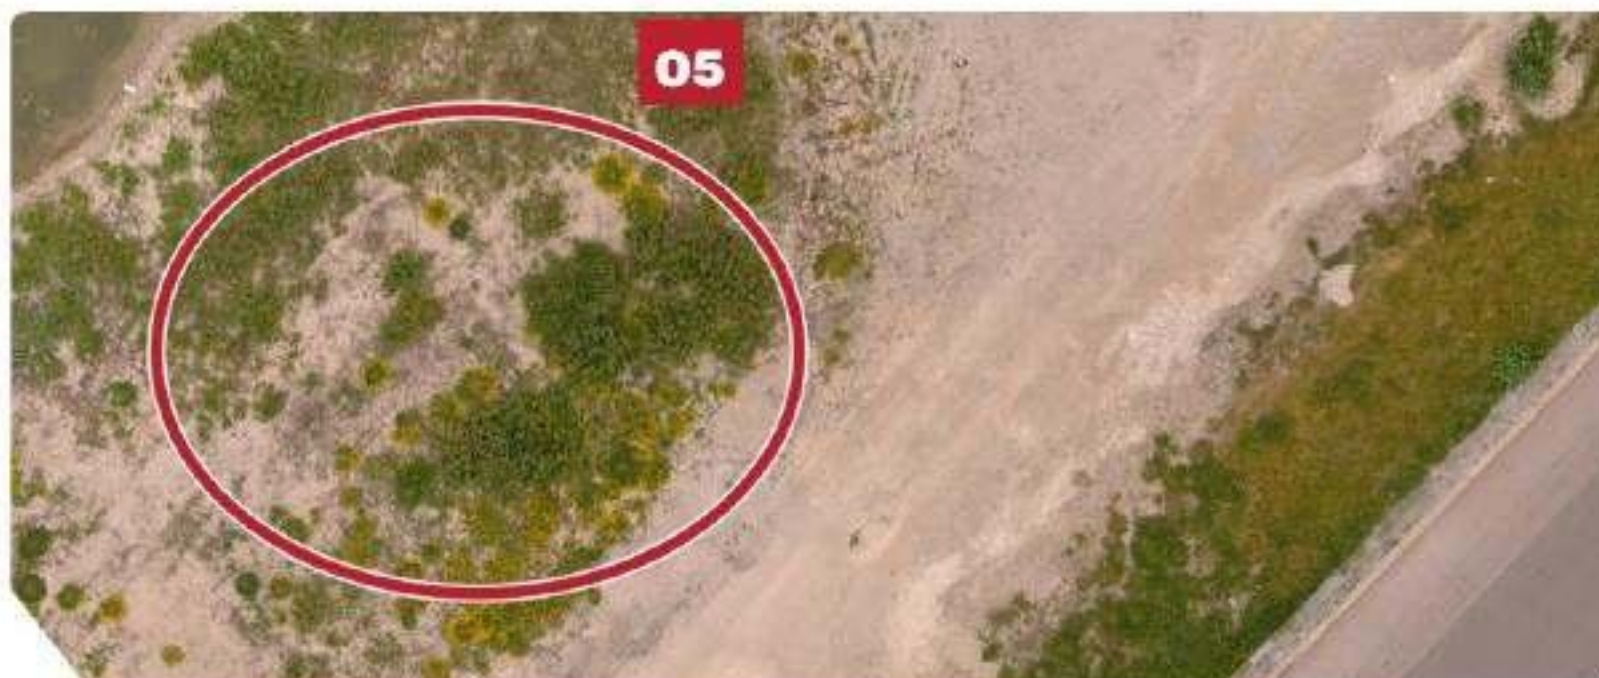
Weeds and grasses, including yellow-flowering plants, are colonising the stripped ground and the edges of the stockpiles.

Weed cover hides the ground surface and can spread seed into finished areas. On the other hand, some cover reduces dust and erosion while the site sits idle.

05.1 – Weeds establishing on the southern work area.

Decide whether to treat the cover as temporary stabilisation or to cut or remove it. Keep haul routes and pile toes clear.

**Timeframe:** Routine maintenance
