**Sample Site**  
Greater Toronto Area, ON

SAMPLE REPORT · CLIENT DETAILS REMOVED

# Aerial Site Survey & Mapping Report

Orthomosaic, elevation models, contours, 3D point cloud and mesh, stockpile volumes and a repeat-survey baseline, all produced from a single drone mapping flight.

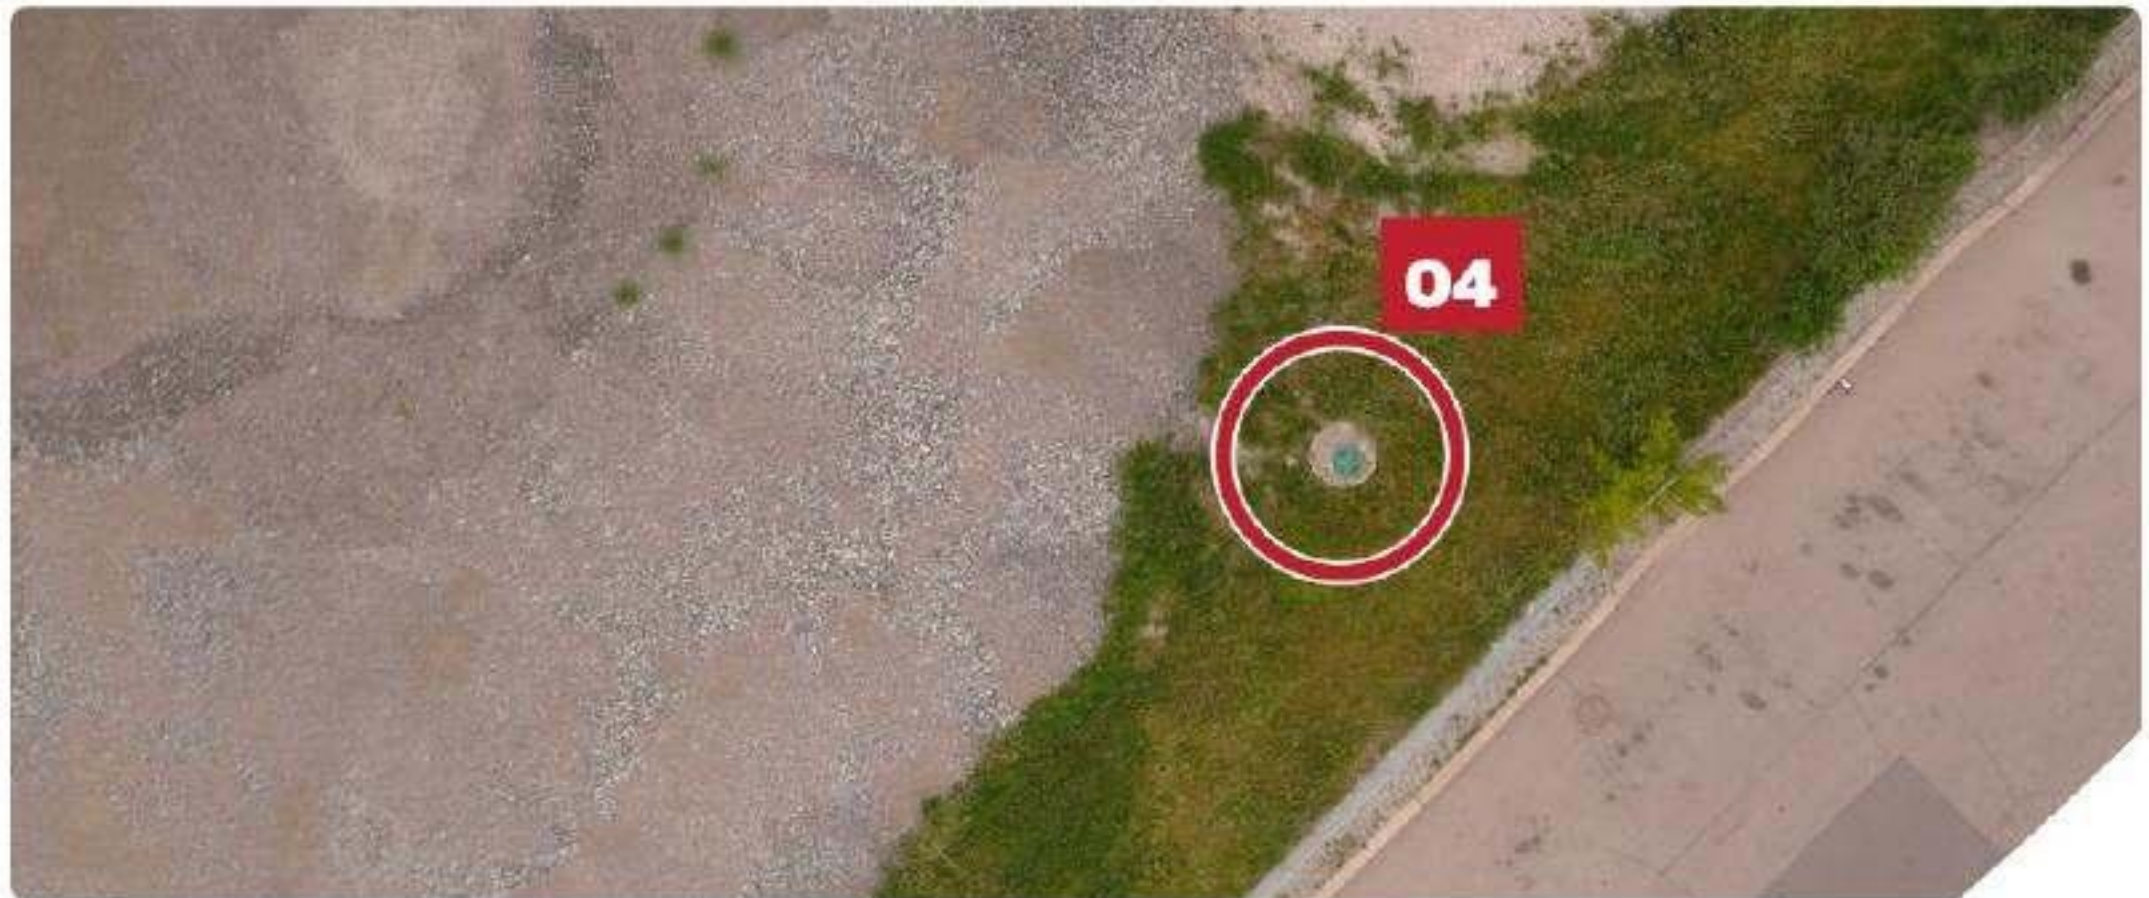
Round utility access covers are visible about 4 m from the toe of SP3 and in the grassed area next to the parking frontage.

Covers near stockpile toes and haul routes can be buried, damaged or driven over by equipment.

04.1 – Access cover in the boulevard, about 4 m from the SP3 toe.

Mark the covers, confirm the owner, and keep them clear of stockpile toes. Obtain utility locates before any grading near them.

**Timeframe:** Within 12 months / before grading

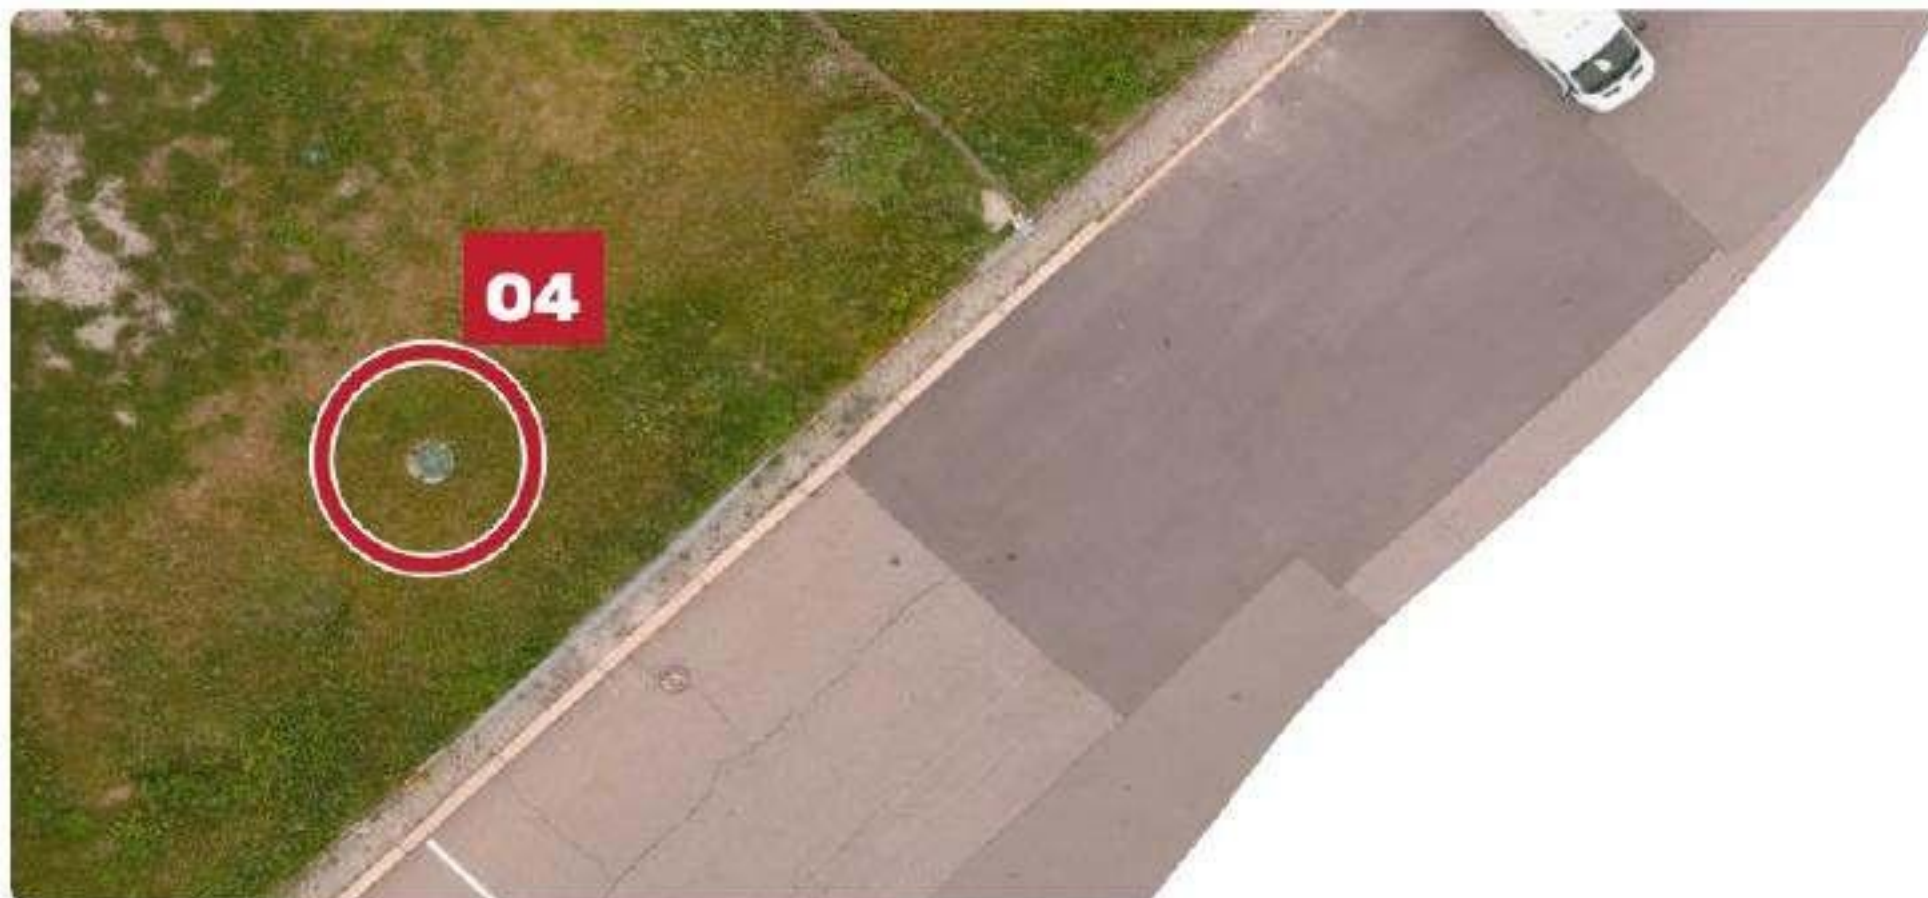
04.2 – Access cover in the grassed area near the parking frontage.

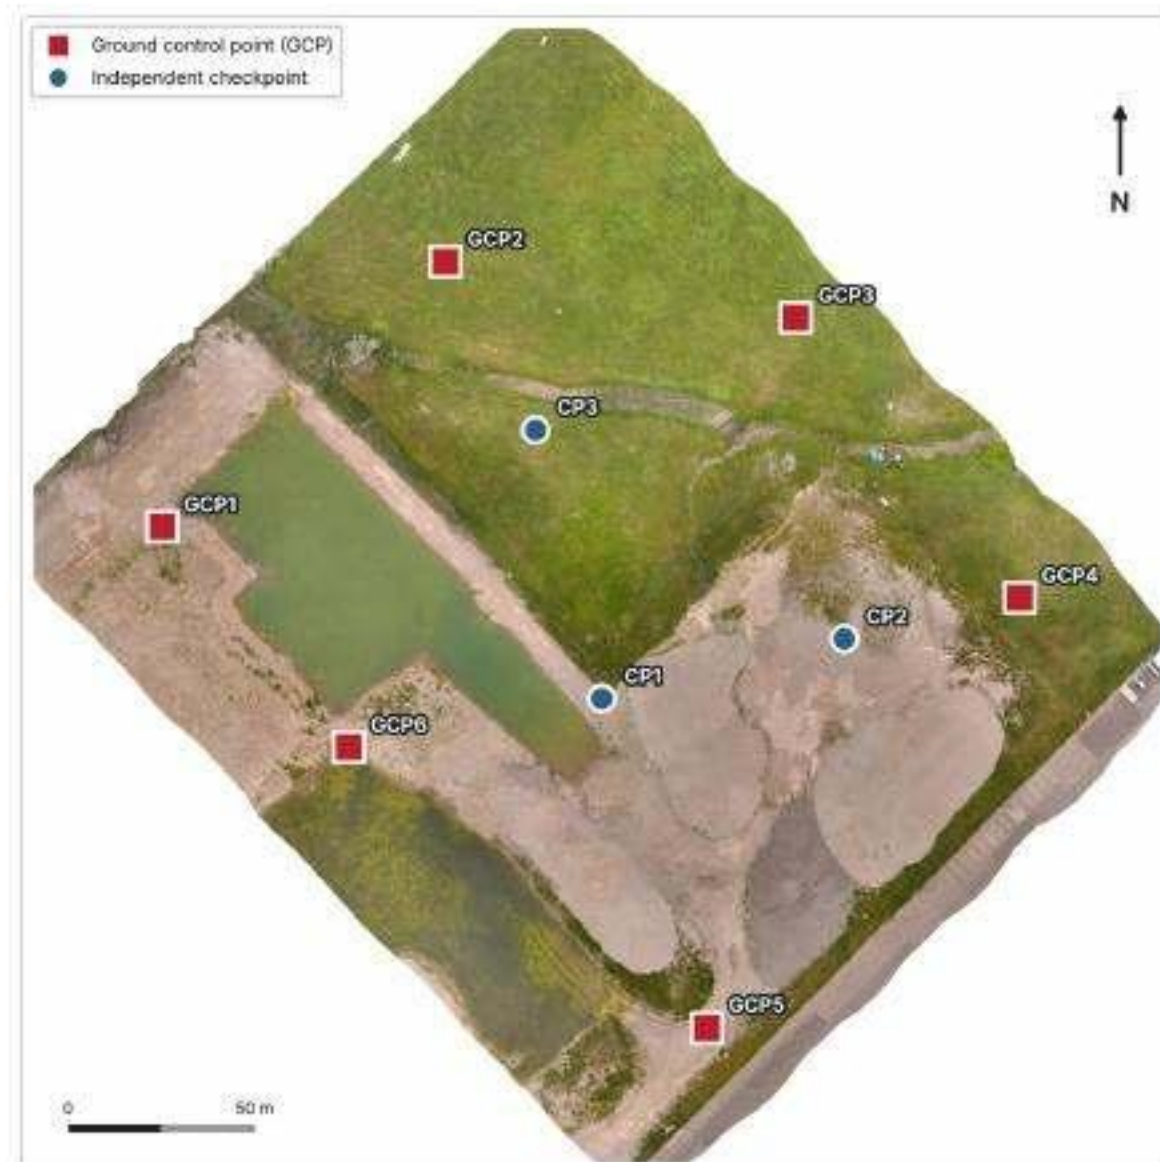
**Figure 9.1** · Recommended ground control (6) and checkpoint (3) layout for the next visit:

**To reach survey grade on Visit 02:** place 6 GCPs and 3 checkpoints as shown, surveyed with RTK GNSS to NAD83(CSRS) / CGVD2013, or fly an RTK/PPK-equipped aircraft. Both visits can then be tied to the same datum.

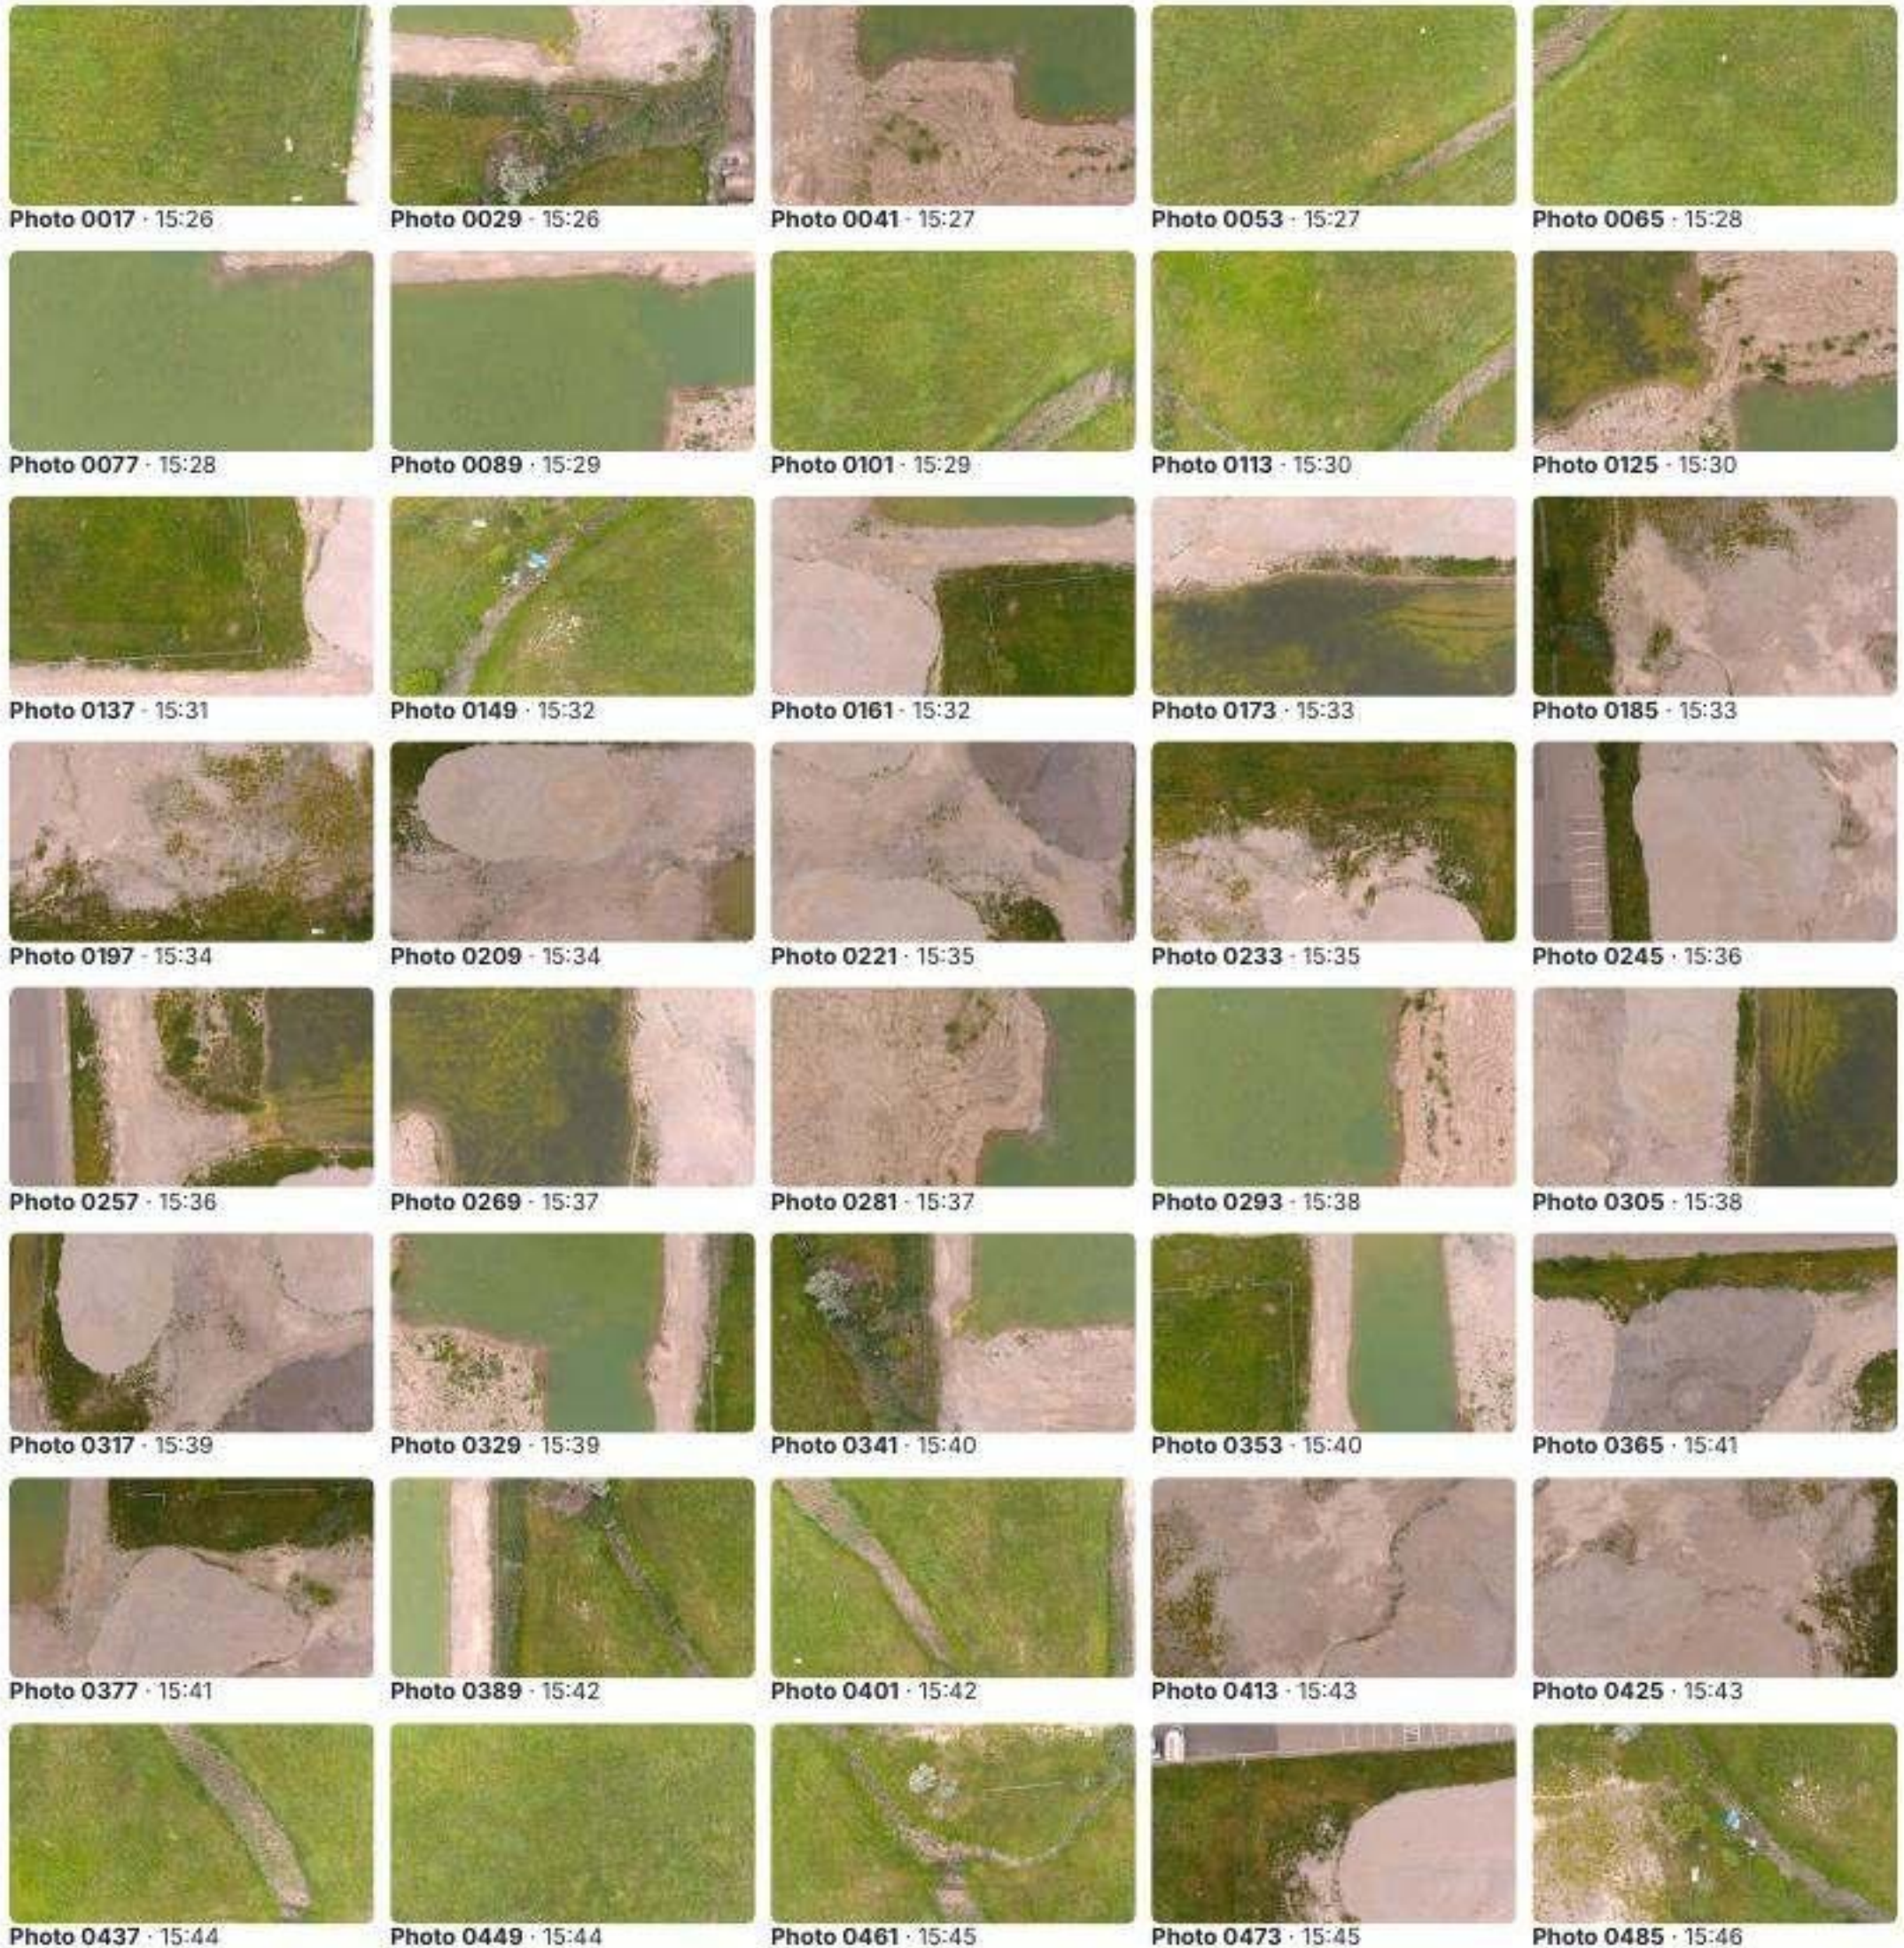
# Flight & Photo Log (40 of 485)

Every 12th image of the 485-image mapping flight, in capture order (local time). The full raw image set is included in the data package.
