**Sample Property**

Greater Toronto Area, ON

SAMPLE REPORT · CLIENT DETAILS REMOVED

## Aerial Roof Inspection Report

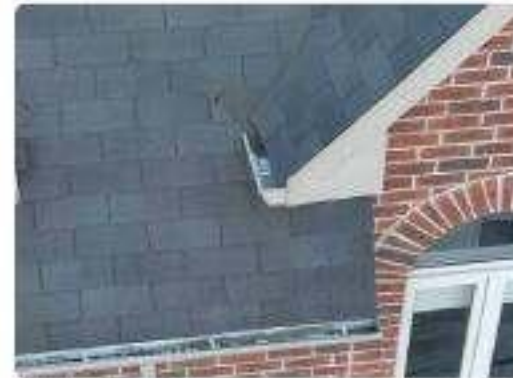
**Photo 14 · F6**  
Front mansard slope & dormers

# F6 Eavestroughs with debris, granule build-up and staining

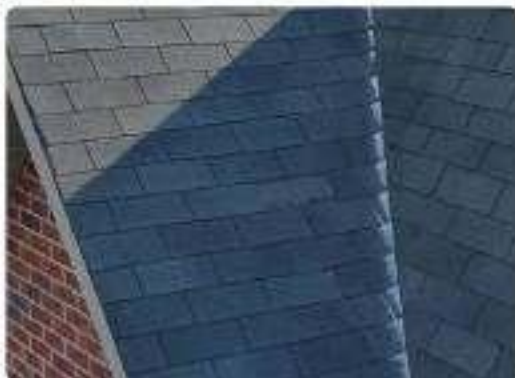
**Photo 23 · F3**  
Front mansard slope & dormers

Numerous light-coloured spots arranged in vertical lines are visible on the shingle tabs, consistent with exposed (face-nailed) fasteners or sealant dabs from past repairs. Darker replacement shingles that do not match the surrounding field, and a section with a visible tar line across the tabs, also indicate previous patching.

Exposed fasteners and surface sealant are not a permanent watertight repair. Sealant shrinks and cracks with UV exposure and freeze-thaw cycles, and each exposed nail is a potential leak point. Clusters of repairs can also indicate a recurring problem area.

**F3.2** – Repaired shingles with face nails and a visible tar line.

Have a roofer verify the repairs up close. Replace face-nailed shingles with properly nailed, sealed shingles, or at minimum re-seal all exposed fastener heads. Ask the owner or previous contractor whether there is a history of leaks in this area.

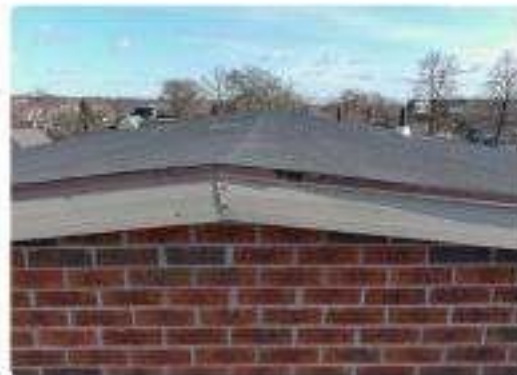
**Photo 102 · F1, F8**  
End wall, rake & perimeter

Rust-coloured staining is visible at several exposed screw heads on the pre-finished metal trim.

Mainly cosmetic, but corroding fasteners can loosen over time and allow trim to lift in high winds.

**F8.1** – Rust-stained screw heads on the gable-end trim.

Replace corroded screws with stainless or colour-matched coated fasteners when other repairs are carried out.
